## Roof Inspection Report

**1635 Clearview Drive, San Leandro**

Kane Howell  
May 21, 2020  
Reg No. 121052 SP

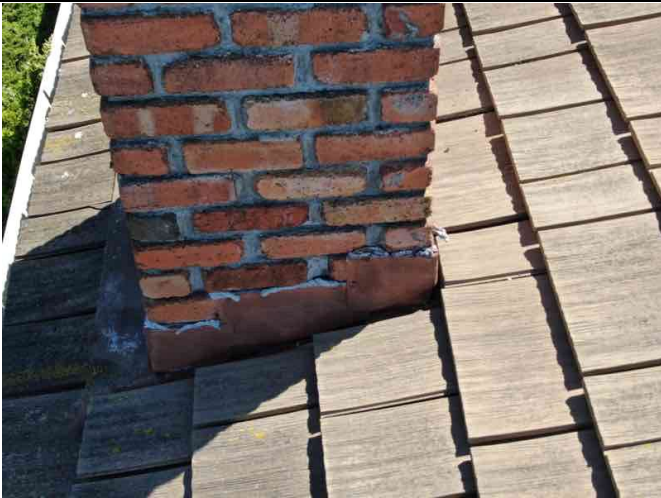
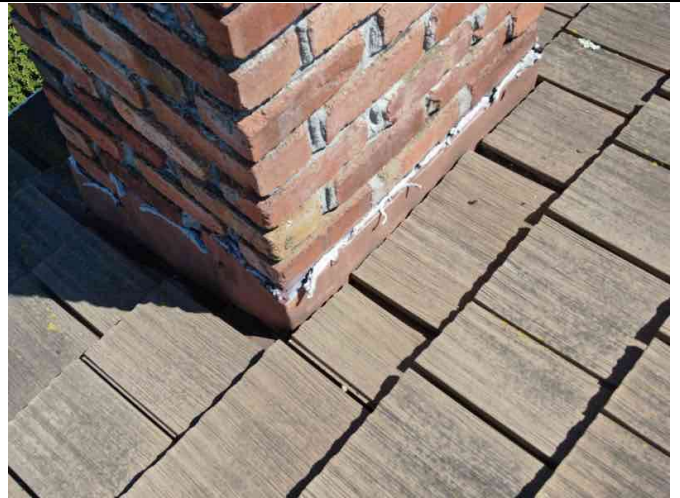
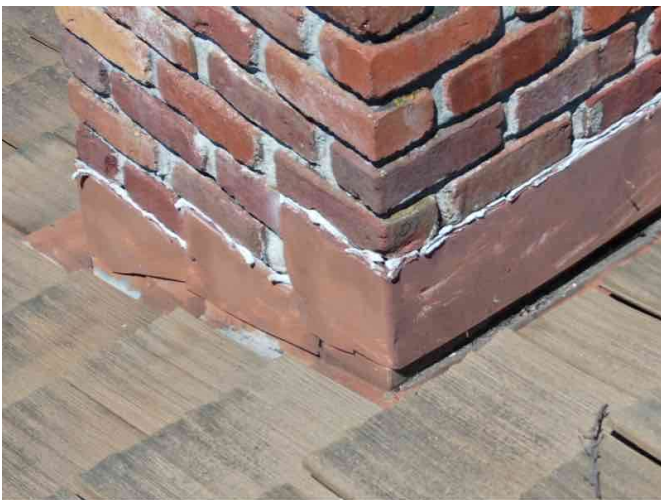
1. Birds eye view (See Photo 1) (See Photo 2) (See Photo 3)
2. General roof photos: (See Photo 4) (See Photo 5) (See Photo 6)
3. The chimney counter flashing requires sealing. (See Photo 7) (See Photo 8) (See Photo 9)
4. Debris is impeding water travel at the valley. (See Photo 10)
5. During the course of the inspection we noted broken ridge tile(s). (See Photo 11)
6. During the course of this inspection we noted broken field tile(s). (See Photo 12)
