WOOD DESTROYING PESTS AND ORGANISMS INSPECTION REPORT

Building No. 1635	Street Clearview Drive	City San Leandro	ZIP 94577	Date of Inspection 05/21/2020	Number of Pages 5
----------------------	---------------------------	---------------------	--------------	----------------------------------	----------------------

Report # : 10436

CORRECTED REPORT

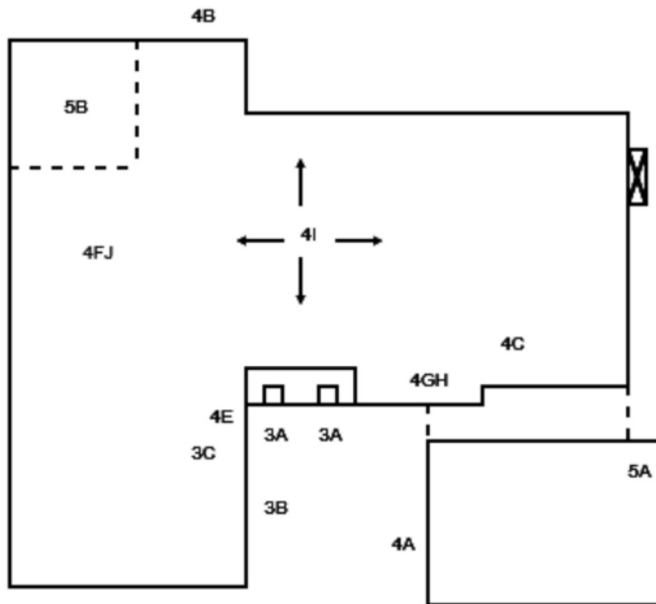
Diagram Not To Scale

FINDING: The areas of the walls and foundation in the garage are inaccessible due to cabinetry is as noted in the diagram.

RECOMMENDATION: The owner should remove the cabinetry and call for further inspection of the garage. For an additional charge not to exceed the cost of the original inspection, the garage will be inspected and a supplemental report will be issued and any findings and recommendations will be listed along with estimates for repair and/or treatment, if within the scope of this company's operations.
