SUPERIOR HOME SOLUTIONS

Home Inspection Report

Property Address:
2370 Scout Street
Oakland, CA 94611

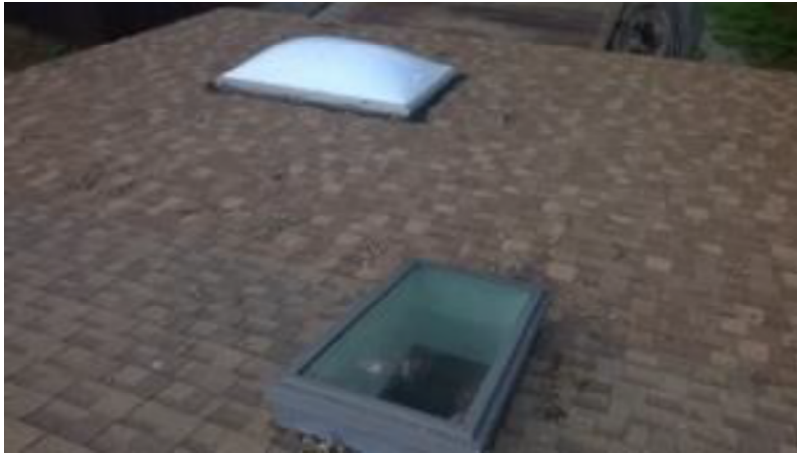
The roof covering is an Architectural Composition Shingles. The overall condition is described as good. The underlayment is without tears and rotted spots. No active water intrusion noted through the shingles. See 1.0 photo 1 to 3 below.

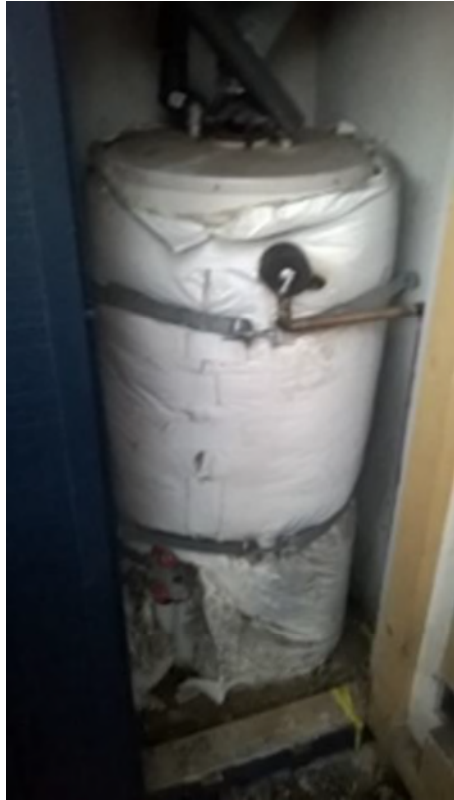
The water heating unit is outside. The unit is operational. No leaks were noted. The hot and cold water inlet are both operational. The drain valve is intact. The gas line is properly attached without any corrosion. The heating element is okay. The heating/cooling drain pipes are operational. No leak or calcification noted on any of the galvanized or copper piping. See 6.1 photo 1 below.

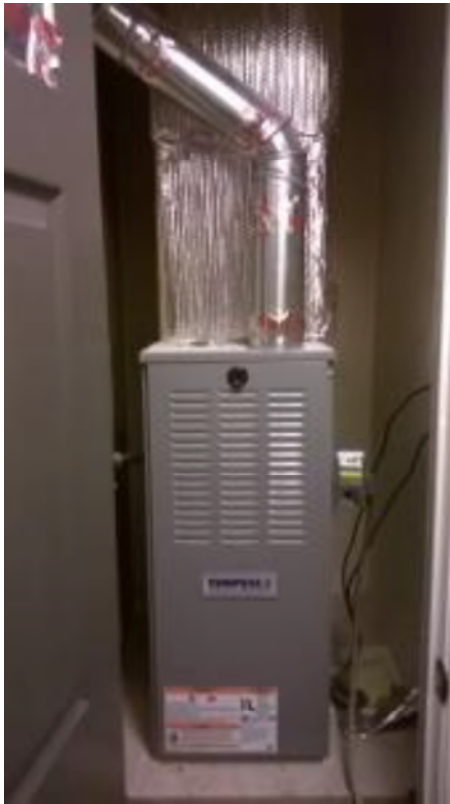
The heating furnace was tested and operational at the time of the inspection. No leaks detected or disruption in the flow noted. The compressor, fan, and coil are operational. See 8.0 photo 1 below.
