WOOD DESTROYING PESTS AND ORGANISM INSPECTION REPORT

Building No. 299	Street Via Cima Court	City Danville	ZIP 94526	Date of Inspection 9/4/2018	Number of Pages Page 1 of 11
<div style="display: flex; align-items: center;"> <div> 58 Wright Brothers Avenue Livermore, CA 94551 (855) 331-1900 • Fax (925) 294-1818 </div> </div>					
Registration #: PR1452		HomeGuard #: 464935		Escrow #:	
Ordered By: Roger Clark Lifestyle Real Estate Service, I 4101 Dublin Boulevard #F506 Dublin, CA 94568		Property Owner/Party in Interest: <div style="background-color: black; width: 200px; height: 60px; margin: 5px;"></div>		Report Sent to: Shilea Venti Fidelity National Title 1340 Treat Boulevard #130 Walnut Creek, CA 94597	
COMPLETE REPORT <input checked="" type="checkbox"/> LIMITED REPORT <input type="checkbox"/> SUPPLEMENTAL REPORT <input type="checkbox"/> REINSPECTION REPORT <input type="checkbox"/>					
General Description: One story, single family wood framed residence with stucco and wood siding.				Inspection Tag Posted: Subarea Other Tags Posted: None noted

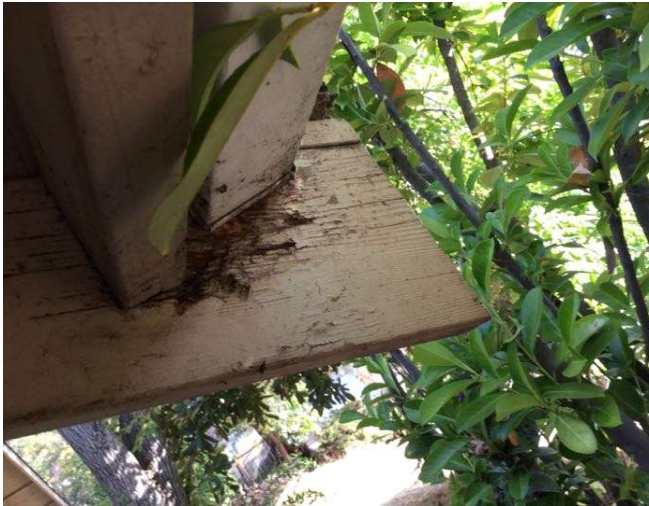
Picture 1

1A. FINDING: Fungus damage was noted to the barge rafter(s) as indicated on the diagram.
(See Picture 1)

RECOMMENDATION: Remove and replace a section of the damaged barge(s) rafter to correct this condition. This bid includes repair of the roof covering if disturbed by our repairs. If existing gutters need to be removed to perform the repairs then our bid also includes reinstallation of original gutters. If it becomes necessary or desirable to install new gutters this will be done only if authorized and at an additional cost. The guarantees on the roof covering are limited to the areas where the work was performed

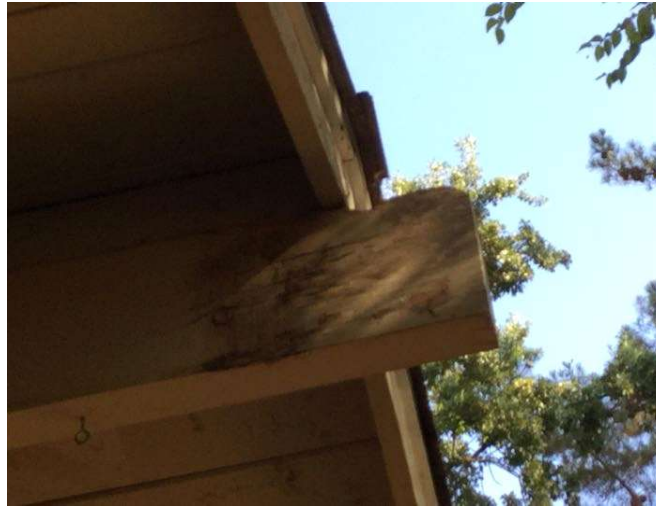
Picture 2

1B. FINDING: The beam has been damaged by fungus where indicated on the diagram. (See Picture 2)

RECOMMENDATION: Remove and replace all the damaged wood members. If any damage is found to extend into any enclosed areas a supplemental report and bid will be issued.

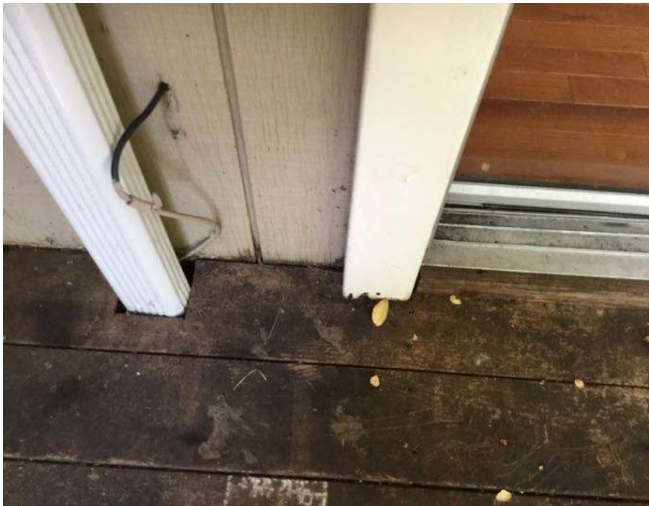
Picture 3

1C. FINDING: The trim has been damaged by fungus where indicated on the diagram. (See Picture 3)

RECOMMENDATION: Remove and replace all the damaged wood members. If any damage is found to extend into any enclosed areas a supplemental report and bid will be issued.

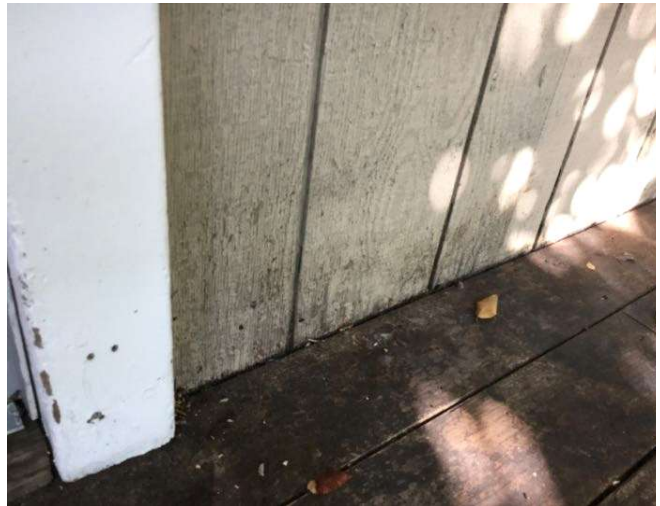
Picture 4

1D. FINDING: The wood siding has been damaged by fungus where indicated on the diagram.
(See Picture 4)

RECOMMENDATION: Cut off approximately 1-3 feet of the siding to eliminate the damage. Install Z-bar and new siding where removed. If damage extends into inaccessible areas, a supplemental report will be issued with any findings, recommendations, and bids to complete repairs. It should be noted that an exact match of the existing siding may not be possible.

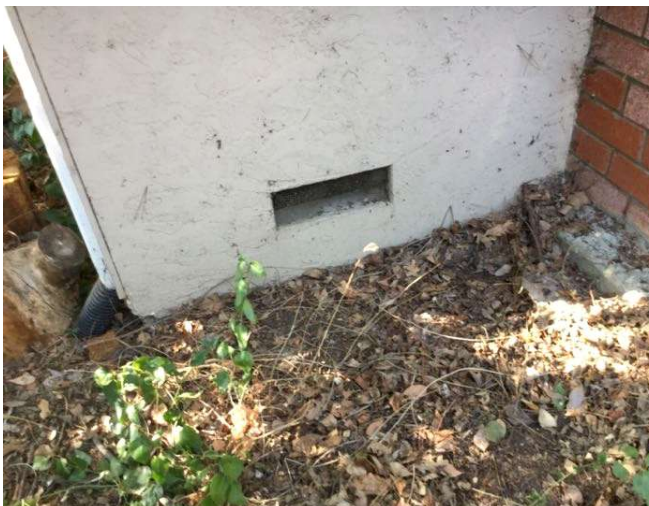
Picture 6

- 3A. FINDING:** This home was constructed without the use of a weep screed at the base of the stucco. Although this was an accepted construction method it does create an area that can allow subterranean termites to access the home without being detected. This area can also allow condensation to build up and not drain properly. (See Picture 6)

RECOMMENDATION: If further information is desired it will be necessary to install a series of test holes to allow for further inspection. All findings recommendations and bids will be issued in a supplemental report.

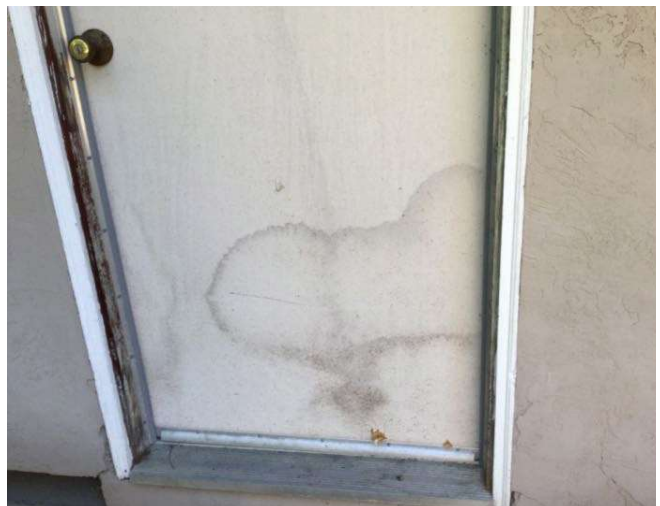
Picture 7

1E. FINDING: The hall bathroom and side bonus room doors have been damaged by fungus.
(See Picture 7) (See Picture 19)

RECOMMENDATION: Supply and install new doors. We intend to reuse the existing hardware. We at HomeGuard Incorporated are upgrade experts and can provide proposals that include tile, marble, granite, upgraded fixtures, upgraded windows and doors or any other option you may desire.

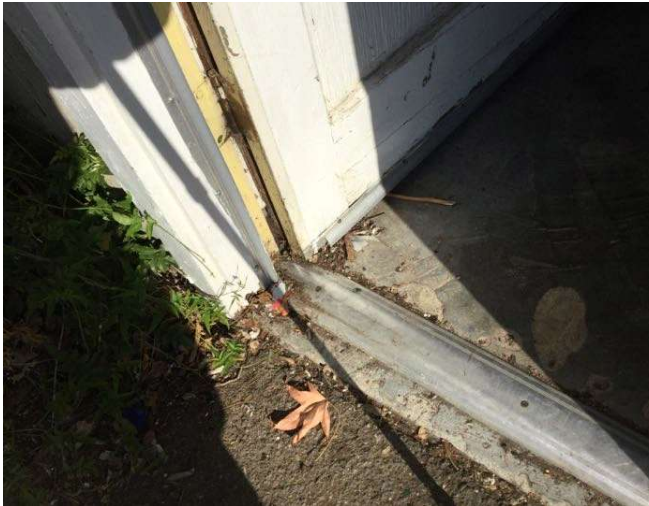
Picture 8

1F. FINDING: The bonus room door jambs are fungus damaged and subterranean termite damaged. (See Picture 8)

1G. FINDING: Subterranean termites were noted throughout the structure. (See Picture 8)

RECOMMENDATION: Cut off the bottom of the door jambs and fill the void with concrete.

RECOMMENDATION: Chemically treat the entire structure at probable termite entry points for the control of Subterranean termites with Termidor HE(Fipronil:5-amino-1-(2,6-dichloro-4-(trifluoromethyl) phenyl)-4-((1,R,S)-trifluoromethyl)sulfinyl)-1-H-pyrazole-3-carbonitrile and break down and brush away all subterranean termite migratory tubes. In conventional construction, this may include, but is not limited to, rodding or trenching the soil around the foundation walls, piers, and plumbing pipes in the subarea; rodding or trenching the soil around the exterior foundation; drilling attached slabs such as patios, porches, sidewalks, or driveways that abut the structure; drilling brick or stone veneer that extends below grade level; treating voids in the foundation walls or piers. The holes drilled into any concrete slab, while performing the treatments, will be plugged with mortar. It will be the owners responsibility to have these areas repaired to match the existing surfaces as desired. HomeGuard Inc. assumes no liability for any damage to concealed pipes, finished floors, tiles or bricks. NOTE: In order to perform this treatment the property must be vacant for the period during and 3 hours after the treatment has been completed. HomeGuard will use a ground fault device to hopefully prevent drilling through any pipes, conduit or electrical wiring however if this were to happen it will be the owners responsibility and expense to repair any damage done.

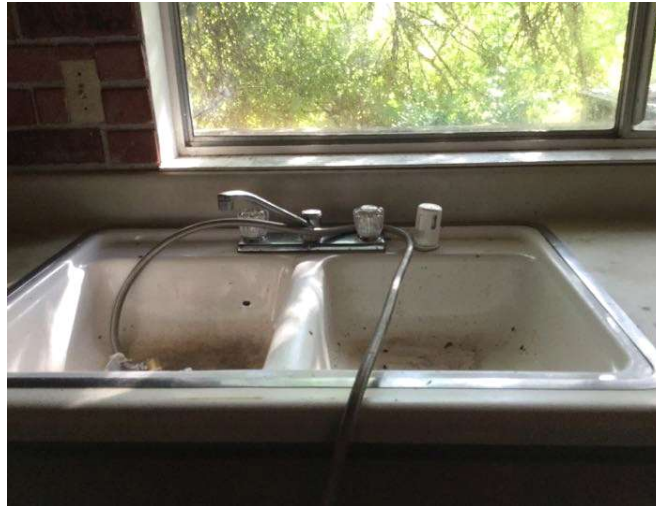
Picture 10

- 3B. FINDING:** The water was turned off at the time of our inspection and we were unable to water test the areas that are normally tested in a termite inspection. (See Picture 10)

RECOMMENDATION: Further inspection recommended. The owner should have the water turned on and HomeGuard Incorporated will return and inspect the areas that are normally water tested and issue a supplemental report with any findings, recommendations, and bids.

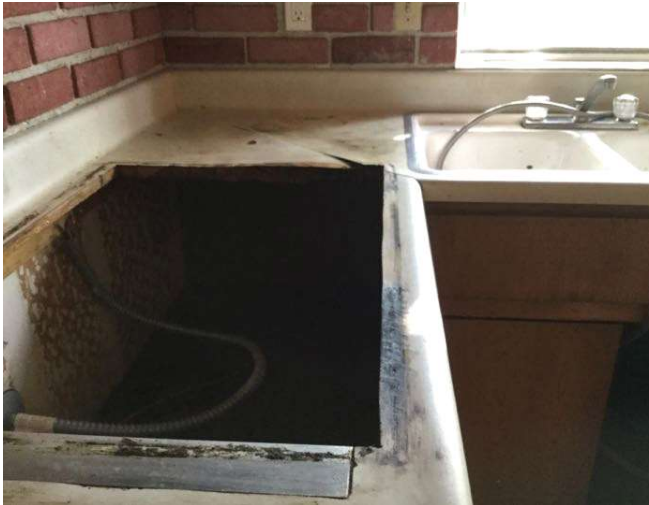
Picture 11

1H. FINDING: The counter top was noted to be fungus damaged in the kitchen. (See Picture 11)

RECOMMENDATION: The owner is advised to contact the appropriate trades to replace the delaminated counter top with new materials.

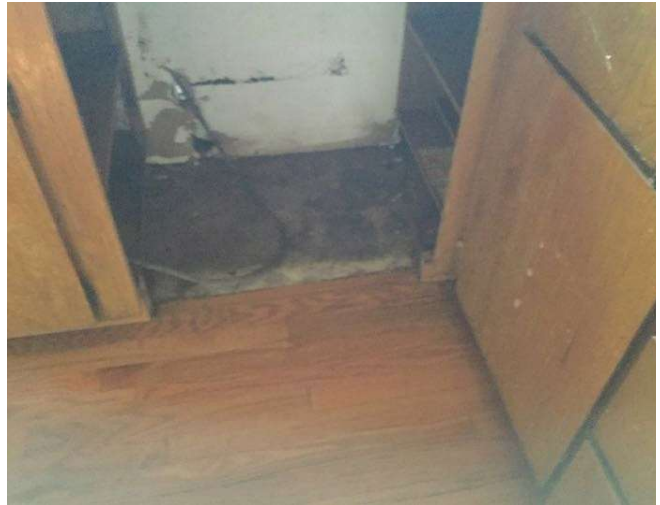
Picture 12

1I. FINDING: The kitchen floor is fungus damaged adjacent to the cabinet. (See Picture 12)

RECOMMENDATION: Open the floor to repair damaged underlayment as necessary. Install new underlayment and new standard grade neutral colored vinyl floor covering over the floor area. When the underlayment is removed, if fungus damage to the subfloor or walls is revealed, we would issue a supplemental report and bid. It will be the owner's responsibility to remove and reinstall all appliances and furnishings. If this property has a dishwasher, it may be necessary to remove it in order to properly affect this repair. In the event that we remove the dishwasher, we will reinstall it. If the dishwasher is found to be leaking upon reinstallation there will be additional charges to make needed repairs. We at HomeGuard Incorporated are upgrade experts and can provide proposals that include tile, marble, granite, upgraded fixtures, upgraded windows and doors or any other option you may desire.

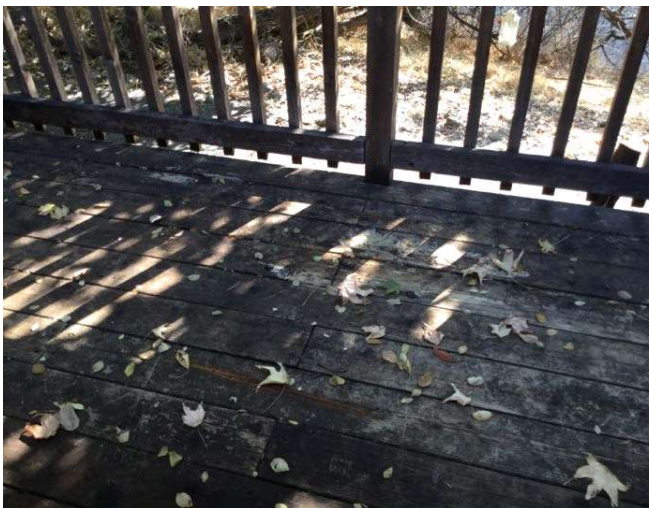
Picture 13

1J. FINDING: A portion under the wooden deck is inaccessible for inspection due to lack of clearance. There is also visible fungus damage. (See Picture 13) (See Picture 14) (See Picture 15)

RECOMMENDATION: In order to make this deck accessible, it will be necessary to remove enough of the decking to expose the framing below. All findings, recommendations, and bids will be issued in a supplemental report.

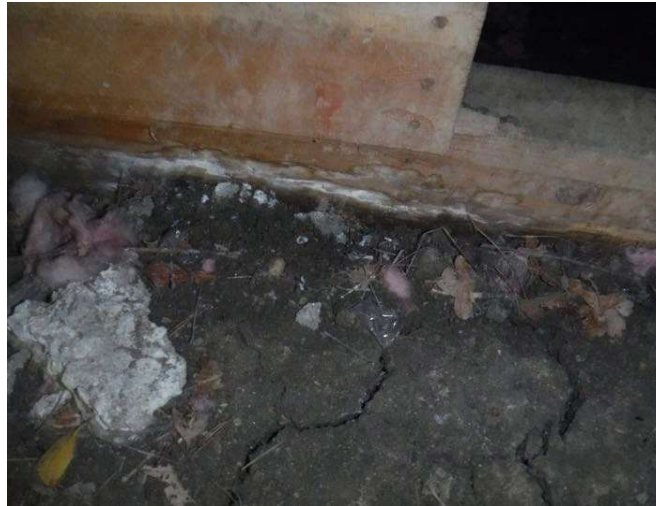
Picture 16

1L. FINDING: The girder, joist, and sill framing have been damaged by fungus at the subarea where indicated on the diagram. (See Picture 16)

RECOMMENDATION: Remove and replace all the damaged wood members. If any damage is found to extend into any enclosed areas a supplemental report and bid will be issued.

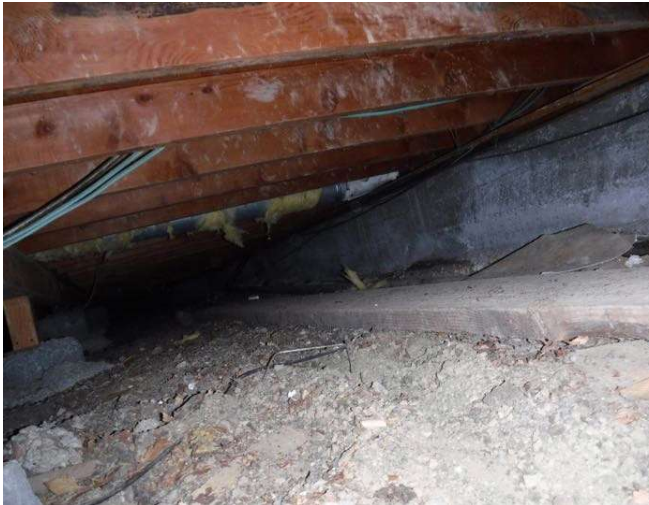
Picture 17

1M. FINDING: There is fungus infected cellulose debris in earth contact in the substructure area. (See Picture 17)

RECOMMENDATION: Remove the cellulose debris of a size that can be raked from the substructure area.

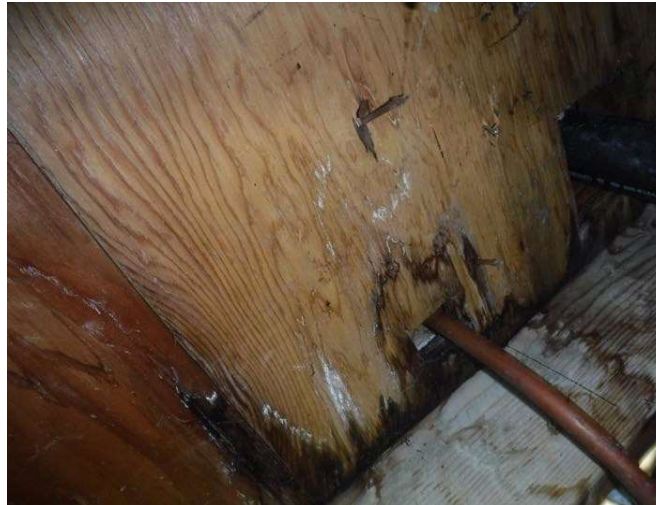
Picture 18

1K. FINDING: Water has gotten under the ceramic tile floor covering in the hall bathroom. This has caused fungus damage to the wood members of the structure. (See Picture 18)

RECOMMENDATION: Remove the toilet and remove the existing tile floor. Remove and replace the damaged wood members. Install a new ceramic tile floor. Unless prior arrangements have been made, all tile is bid using a standard grade white tile with a tight white grout joint. Reinstall the existing toilet using a new no-seep toilet seal. If damage is found to extend into inaccessible areas or if a damaged toilet flange is found, a supplemental report will be issued with any findings, recommendations, and bids. Unless prior arrangements have been made, white tile will be installed. It should also be noted that all tile work regardless of color selection will be done with a tight white grout joint. We at HomeGuard Incorporated are upgrade experts and can provide proposals that include tile, marble, granite, upgraded fixtures, upgraded windows and doors or any other option you may desire.
