# Inspection Report

Report Number:  
**J0728**

**5318 Manila Ave**  
**Oakland, CA**

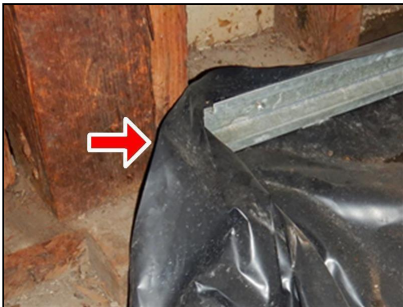
The vapor barrier was attached to the foundation mudsill. This condition is considered to be conducive to pest and moisture damage to the mudsill. We recommend the vapor barrier be properly attached to the side of the foundation to remove any contact with wood framing in the crawl space.

Plastic / wood contact

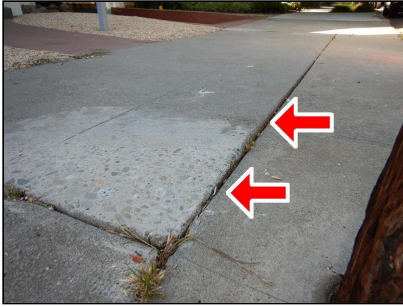
Trip hazards were observed in the public sidewalk adjacent to this building. In most jurisdictions, sidewalk maintenance is the responsibility of the property owner. We recommend removal of all trip hazards for improved safety and to reduce the potential for personal injury.

Trip hazards

As of July 2019, the City of Oakland now requires sidewalk trip hazards to be repaired before close of escrow, or as part of a large remodel. We recommend consulting with the City of Oakland for more information.

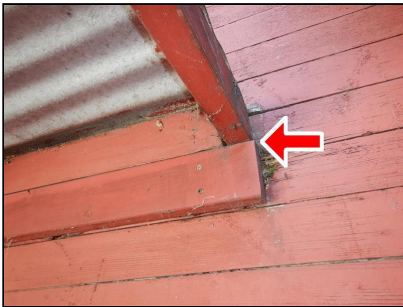
The attachment of the patio cover to the neighbors outbuilding was minimal and will be prone to sagging or failure. We recommend review and repairs as necessary by a licensed contractor.

Weak cover attachment

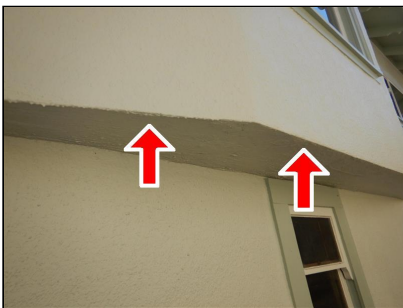
Missing drip edge flashings

As is typical for older buildings, the stucco overhangs were not provided with flashings to create a drip edge. Current standards require flashings to create a drip edge to minimize water entrapment and subsequent damage. To determine if damage is present in these areas, we recommend test-hole openings by a licensed structural pest inspector.

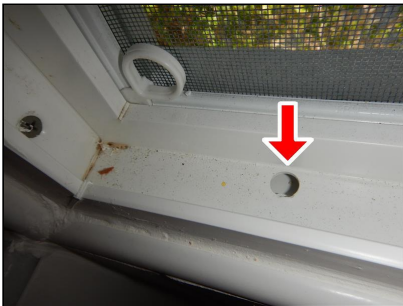
The weep holes in the bottom of the bathroom window were unusual in size and placement, indicating that the holes may have been drilled after manufacture. We recommend further evaluation and testing of the window by a licensed contractor to ensure that it performs as intended.

Unusual weep hole

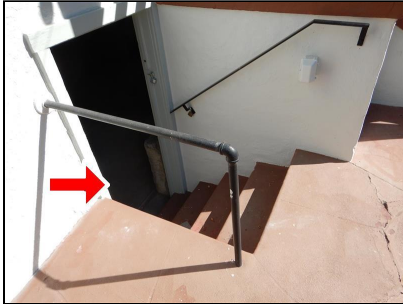
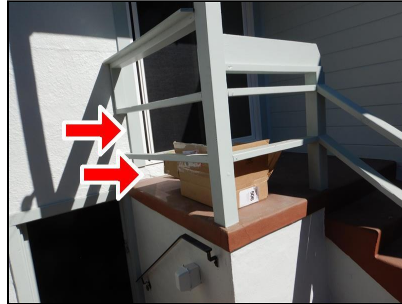
**!** Several railings were hazardous as they could allow small children to fall through. We recommend immediate modification of all railings by a licensed contractor to bring them in conformance with current standards and local requirements to minimize safety hazards.

Open railings

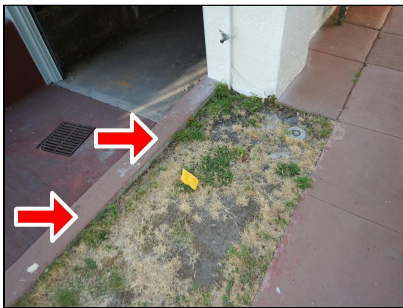
A guardrail was not provided at the right side of the driveway. We recommend the installation of guardrails where needed by a licensed contractor to reduce the potential for personal injury.

Missing guardrail

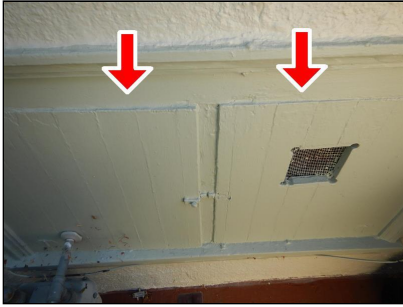
The doors for the exterior cabinets at the right side were painted shut, and the interiors could not be inspected. We recommend further evaluation as hidden defects or damage could exist.

Sealed cabinet doors

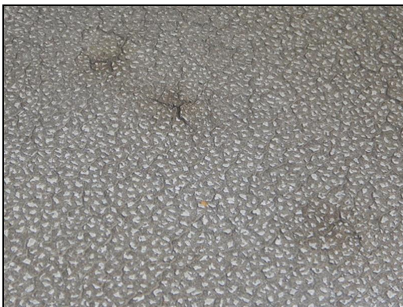
The modified bitumen roofing at the rear addition was generally worn from exposure and was nearing the end of its expected service life. Even with routine maintenance, the need for replacement should be expected within the next few years and we recommend budgeting for this expense.

Worn roofing

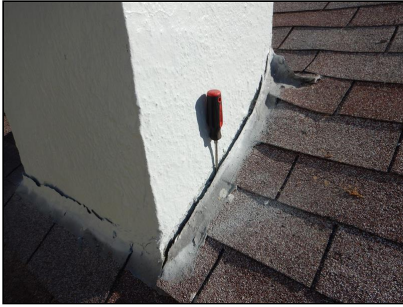
The mastic or sealant used to seal the chimney was cracked or deteriorated. We recommend sealing by a licensed roofing contractor and periodically in the future, as a normal part routine maintenance. As an upgrade, metal flashings should be installed when the roof is replaced for reduced maintenance.

Deteriorated mastic

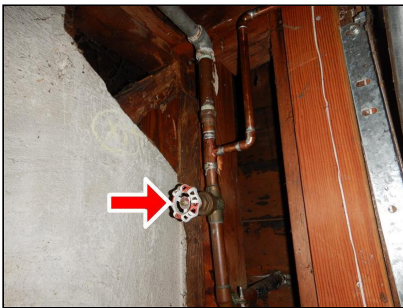
The main water supply shut-off valve was located, but testing the operation of this valve is not within the scope of this inspection. Operation of the valve from time to time will keep it functional and maximize its useful life.

Main water shutoff valve

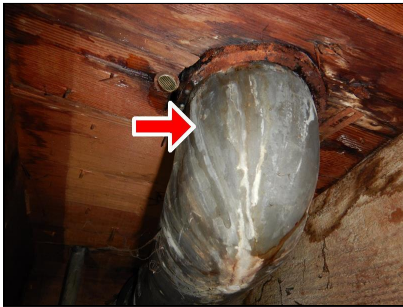
**!** The drain piping was actively leaking below the toilet, creating an unsanitary condition. We recommend immediate repairs or replacement of the damaged / leaking drain piping by a licensed plumbing contractor.

Leaking drain piping

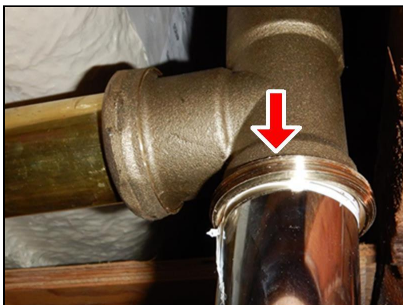
The nut for a slip joint fitting was missing below the bathtub, and this joint could be prone to leaking. We recommend review and repairs as necessary by a licensed plumbing contractor.

Missing slip joint nut

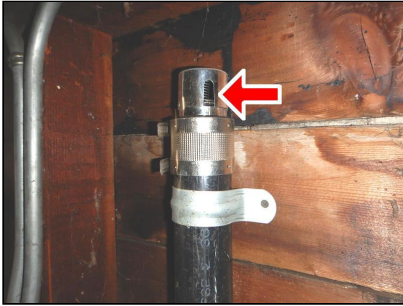
An "in-line" vent was installed at the laundry area. Most municipalities do not allow the installation of such vents because their mechanical parts can fail and allow sewer gases to enter the living areas. We recommend review and repairs as necessary by a licensed plumbing contractor in accordance with current standards.

In-line vent

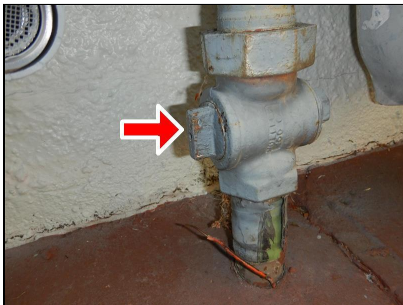
A meter wrench was not located in the vicinity of the main gas valve. A proper wrench should be located near the main gas valve to provide a convenient means for shutoff in an emergency. A main gas valve can be turned 90 degrees in either direction to shut the gas supply off.

Main gas shutoff valve

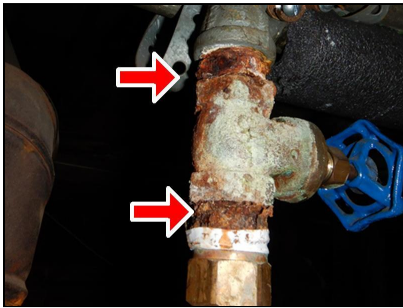
The water connections for the water heater were heavily corroded, and leaks could be imminent. The connections should be examined by a licensed plumber and replaced as appropriate.

Corroded water heater connections

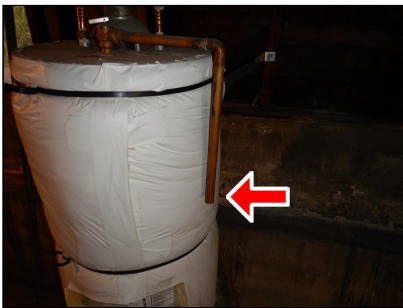
The discharge pipe for the temperature and pressure relief valve for the water heater was too short, creating a potential scalding hazard for anyone in the vicinity during a valve discharge. For improved safety we recommend reconfiguration of the discharge pipe to conform to current standards.

Short discharge pipe

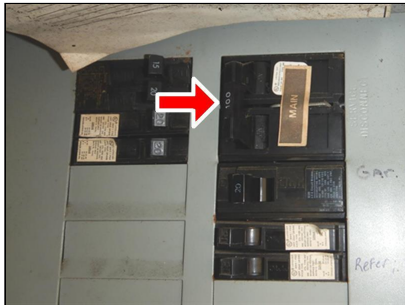
The function of the main disconnect was provided by a two-pole circuit breaker mounted in the main distribution panel. The breaker appeared to be in good condition, although it was not tested during this inspection.

Main electrical disconnect

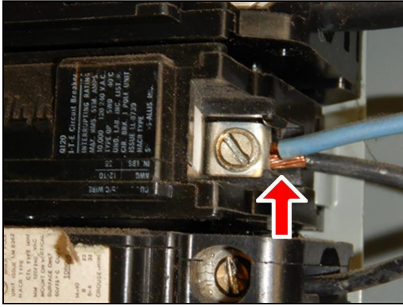
One or more circuit breaker terminals in the main electrical panel had multiple wires installed. Such “double tapping” can be a hazard because positive connection for all the wires at the terminal is not assured. Correction of double tapping requires reconfiguration of all of the affected circuitry so that a single wire only, connects to each circuit breaker terminal. We recommend review and repairs as necessary by a licensed electrical contractor.

Double tapped breaker

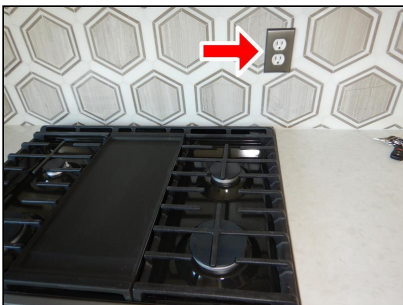
A receptacle was located above the kitchen range. This location is a potential safety hazard as electrical cords can be melted. We recommend moving of the receptacle outlet by a licensed electrical contractor to eliminate this hazard.

Outlet above range

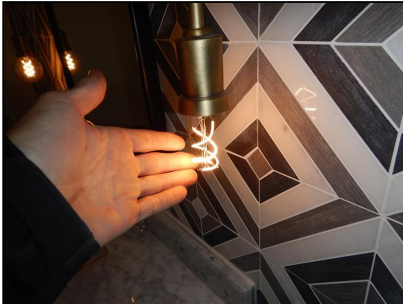
A light bulb in the bathroom was damaged. We recommend replacement as necessary by a licensed electrical contractor to assure that the fixture is safe and dependable.

Damaged light bulb

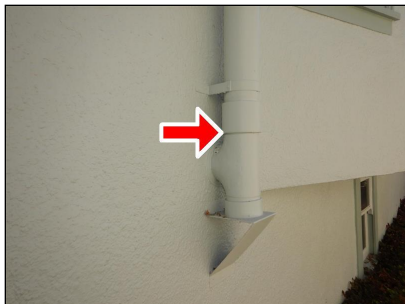
We recommend removal of the abandoned Transite flue at the exterior right side by an asbestos certified contractor. This type of flue likely contains asbestos fibers and the flue should not be disturbed until it can be removed.

Abandoned Transite flue

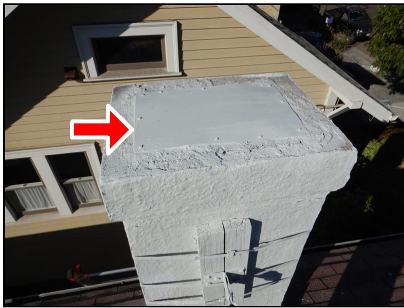
The chimney was capped and it should not be used. If it is desired to restore the function, a licensed masonry contractor should be consulted. Consideration should be given to removal of the unreinforced masonry chimney structure, as it is prone to collapse in a large earthquake.

Capped chimney

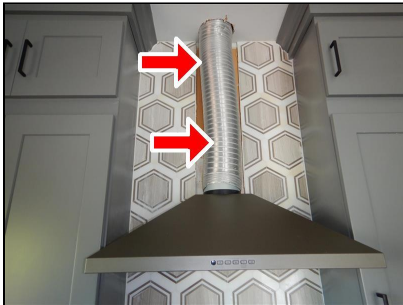
**!** The corrugated flex duct used in the kitchen ventilation system is substandard, as it can allow grease build-up and become a fire hazard. We recommend replacement of this duct with an approved material by a licensed contractor.

Corrugated kitchen vent

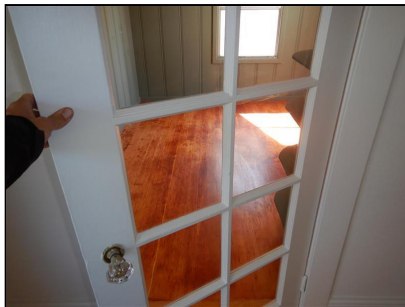
An interior door at the rear addition did not have an emblem to indicate the glass was a safety type. Old doors with plate glass can pose a significant laceration hazard when they break. We recommend upgrading the door with safety glass or the installation of an approved safety film by a licensed glazing contractor.

Unlabeled door glass
