WOOD DESTROYING PESTS AND ORGANISMS INSPECTION REPORT

BUILDING NO. 5318	STREET, CITY, STATE, ZIP MANILA AVENUE, OAKLAND CA 94618	Date of Inspection 7/26/2019	No. of Pages 6
EAST BAY STRUCTURAL & TERMITE CO. INC. 1096 Yerba Buena Avenue, Emeryville, CA 94608 Ph: (510) 652-4712 (510) 652-4790 Fax			
Firm Registration No. PR 4263	Report No. 191658	Escrow No.	
Ordered By: COMPASS REAL ESTATE 1900 MOUNTAIN BLVD. OAKLAND, CA 94611 Attn: SANDY PATEL-HILFERTY	Property Owner/Party of Interest C/O AGENT	Report Sent To:	
COMPLETE REPORT <input type="checkbox"/> LIMITED REPORT <input type="checkbox"/> SUPPLEMENTAL REPORT <input checked="" type="checkbox"/> REINSPECTION REPORT <input type="checkbox"/>			
General Description: SINGLE FAMILY, STUCCO & SIDING EXTERIOR, VACANT		Inspection Tag Posted: BASEMENT	
		Other Tags Posted: Homeguard 4/1/19, Sentinel 6/14/19, East Bay Structural 7/22/19	
An inspection has been made to the structure(s) shown on the diagram in accordance with the Structural Pest Control Act. Detached porches, detached steps, detached decks and any other structures not on the diagram were not inspected.

NOTE: This is a supplemental report for further inspection recommended in

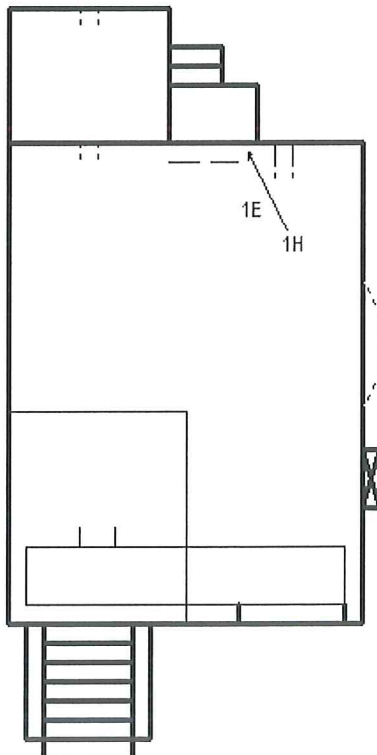
- ITEM 1E Item 1E of the complete report noted fungus and rot damage to the sheathing behind the rear concrete porch. Further inspection was recommended to this location and to various locations throughout the structure. See item 1H for additional information.
- ***** Information Item ***** SEE TEXT
- ITEM 1H Item 1E from the complete report noted fungus and rot damage to sheathing behind the top plate, as seen from the subarea. On this day, further inspection performed above and surrounding this location noted no additional damage where test holes were placed.

RECOMMENDATION: Repairs will be attempted by removing the exterior stucco below the sliding glass door and by removing framing from the subarea to expose the damaged wood members. Cut out the damaged wood members and repair with new materials. Install new waterproof paper, wire and stucco to area below the sliding glass door. Prime paint with one coat of white primer.
