Confidential Inspection Report

LOCATED AT:
6026 W Fir Ave
, California

INSPECTED ON:
Wednesday, November 22, 2017

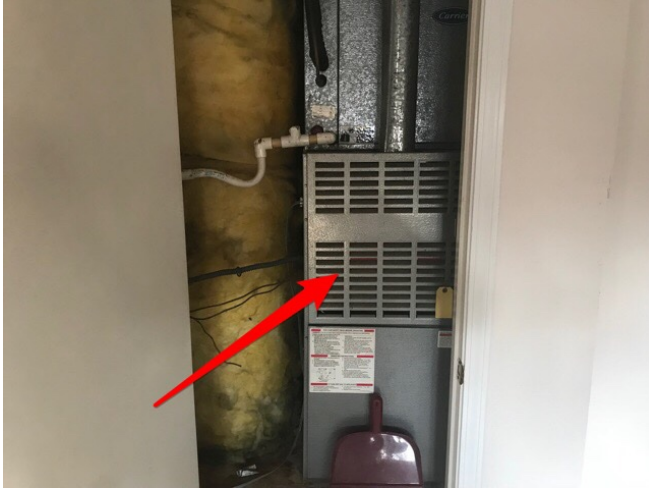
WARN The heating system failed to respond to normal operating controls. We recommend a qualified contractor be retained to evaluate the system and determine what corrective measures are necessary.

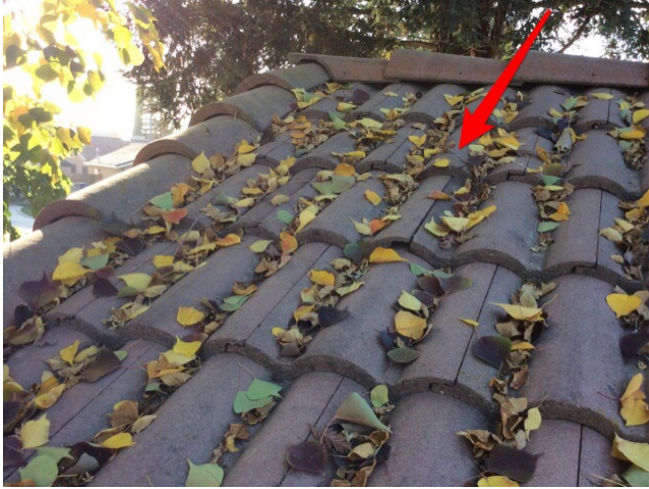
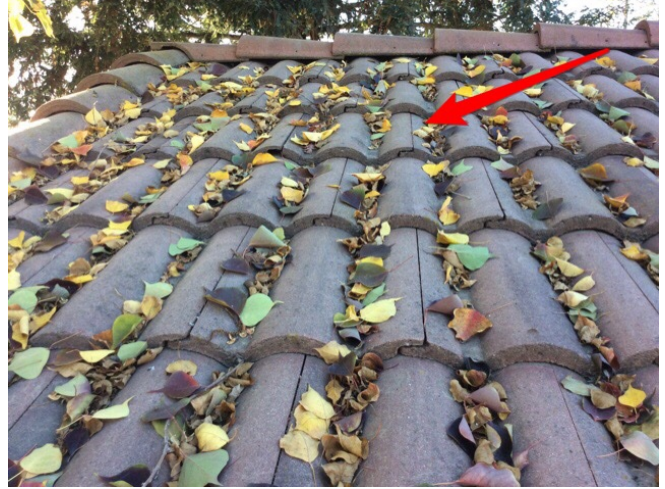
WARN There is debris on the roof, requiring removal to prevent accelerated deterioration of the membrane under the tiles. We recommend that the roof be monitored and periodically cleared of debris in the course of routine property maintenance.

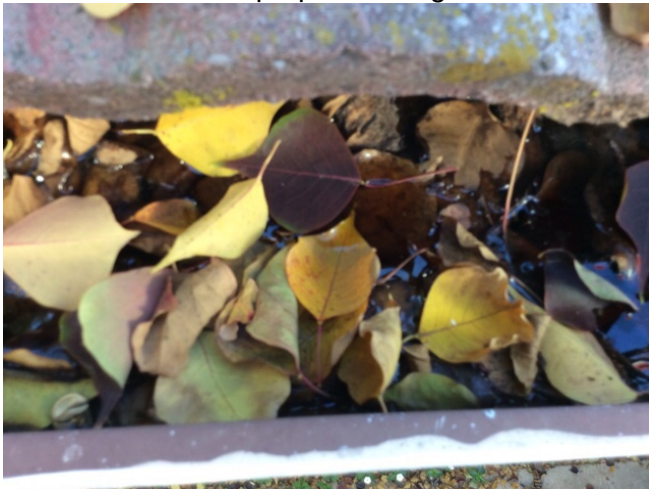
WARN Debris was present in the gutters, which limited our visual inspection. We recommend all debris be removed to ensure proper drainage. The condition of the gutters can be better assessed at that time.

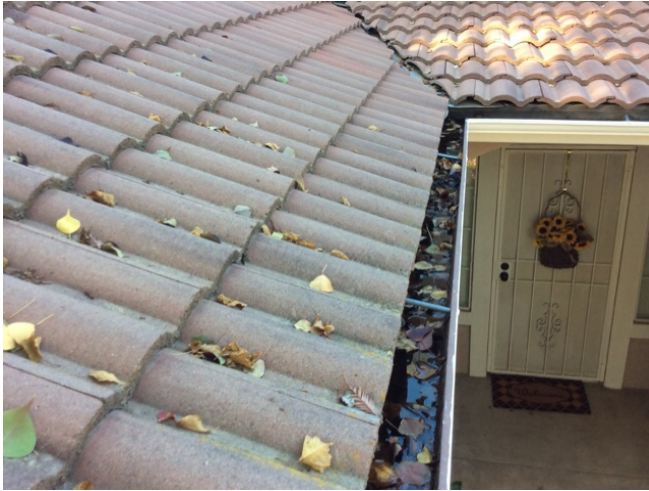
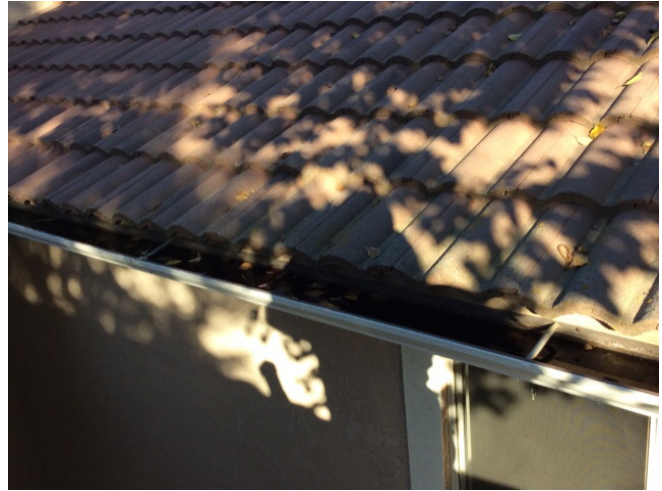
Portions of the gutters were filled with water at the time of this inspection. We recommend all debris be removed and the downspouts be flushed to ensure proper drainage. The condition of the gutters can be better assessed at that time.

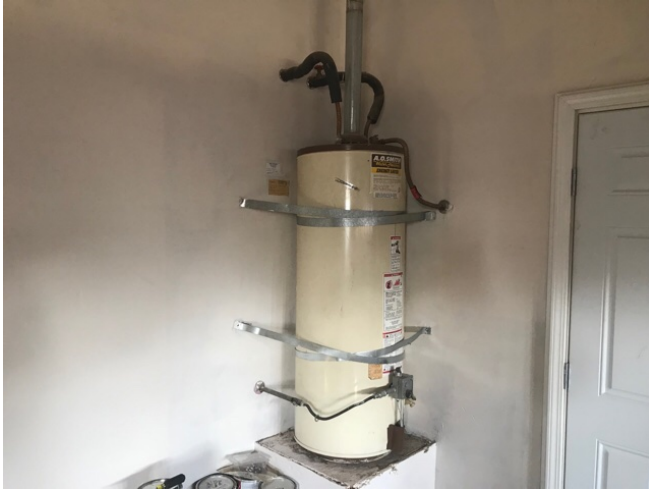
WARN The water heater was operating. However, we recommend your attention be directed to the items noted above. The hammering in the tank is harder elements that have built up on the bottom of the tank.

As preventive measures, we recommend that the water heater be equipped with seismic straps and approved flexible gas and water supply connections.

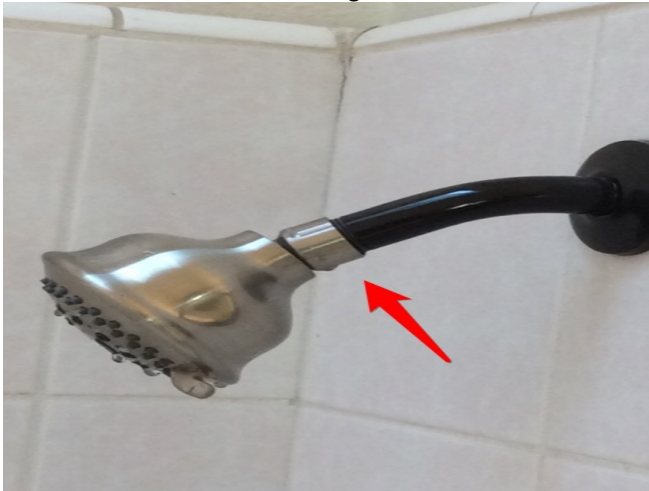
WARN Shower head is leaking.

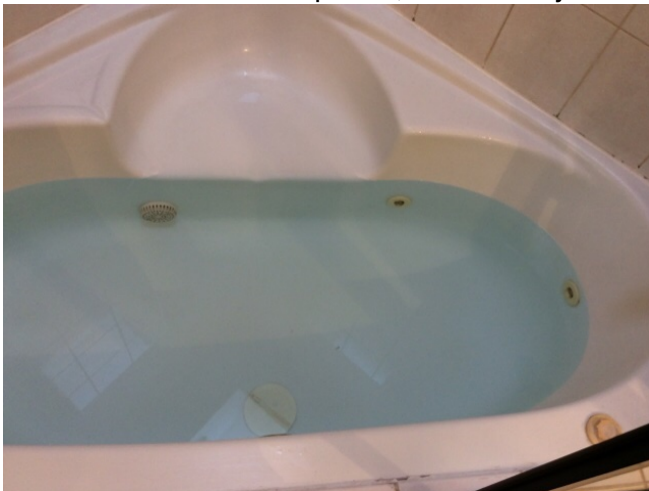
WARN The hydrotherapy tub was not functioning at the time of our inspection. We recommend the tub be further evaluated and repaired, if necessary.

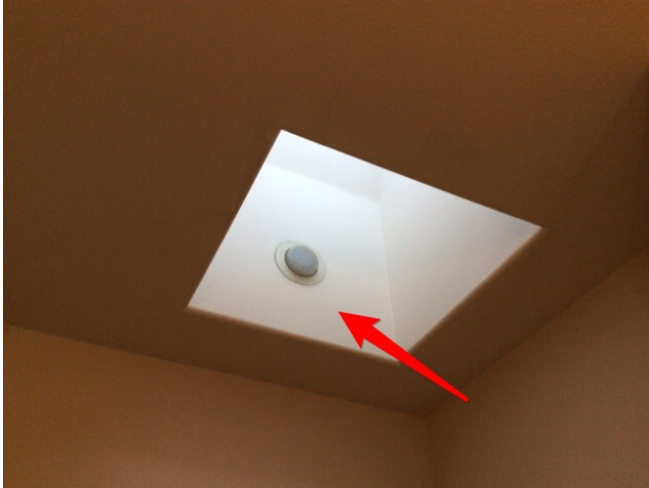
WARN The light fixtures are not working. The bulbs may have burned out. We recommend that the bulbs be tested and replaced, if necessary, and the proper operation of the fixtures be verified.

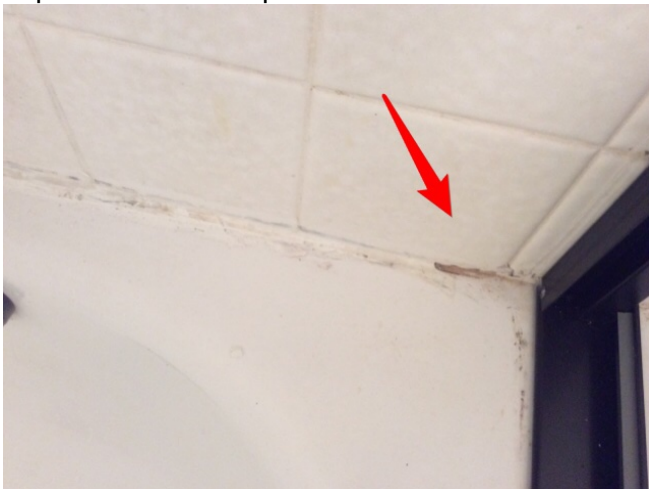
WARN The joint caulking in and around the shower is in poor condition. The enclosure should be recaulked to prevent moisture penetration into the surrounding materials and subsequent damage.

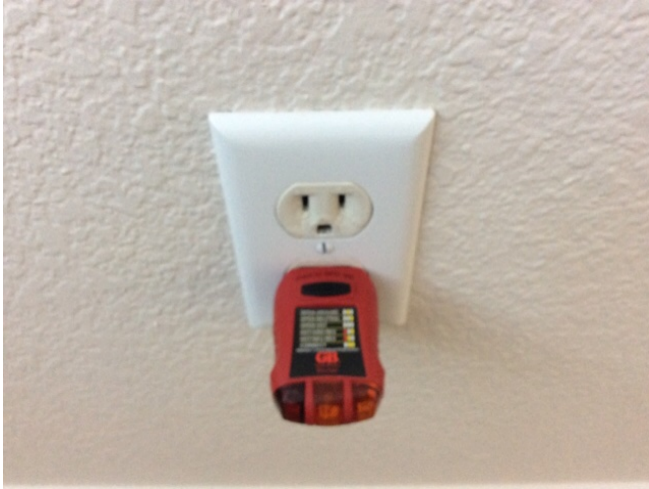
The receptacle at the front right is not working. We recommend further investigation and repair, if necessary.

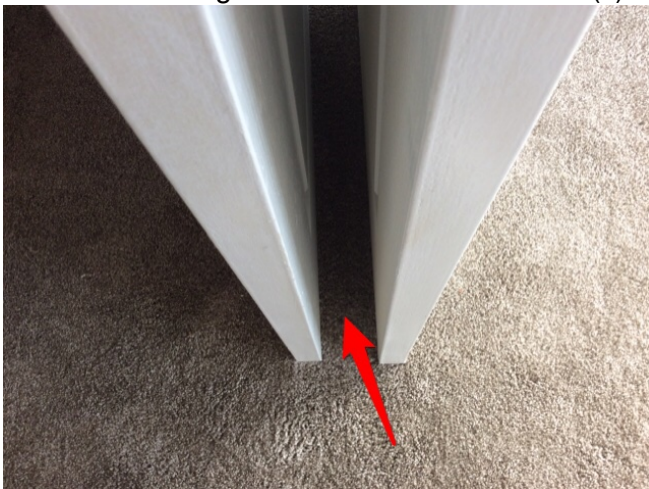
WARN The bottom glide/track on the closet door(s) are damaged and/or missing.

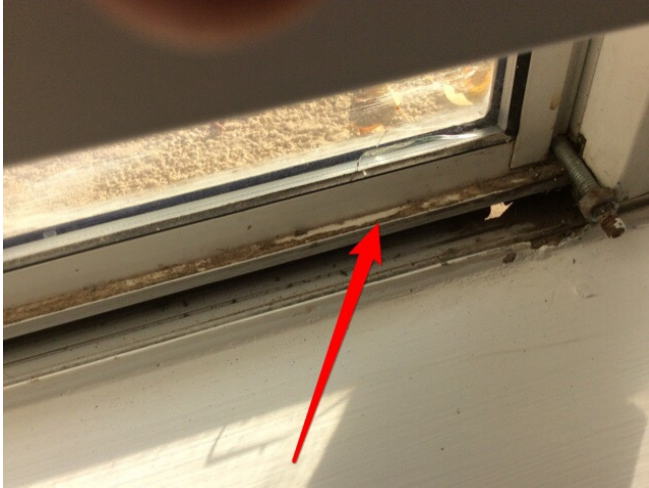
WARN The sliding door does not operate properly, indicating the track is misaligned, dirty, or the wheels are damaged. We recommend repair or replacement.

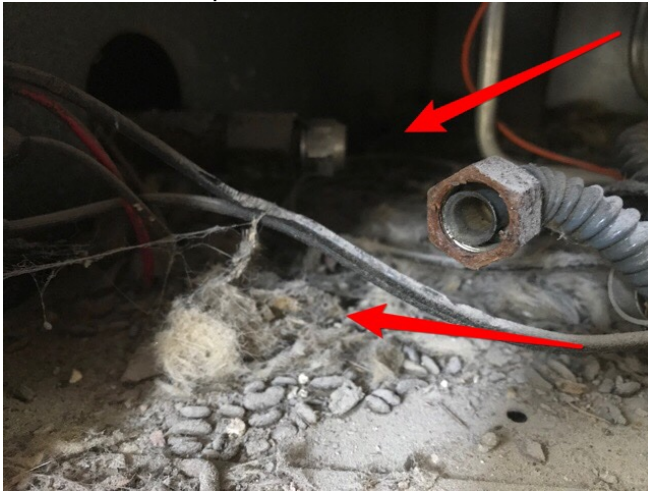
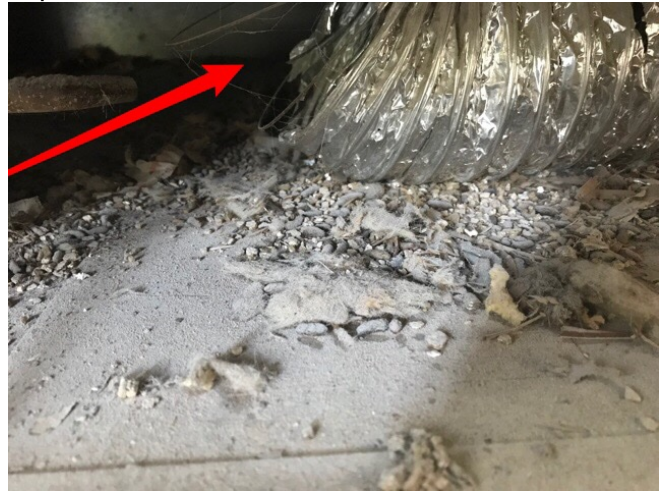
We believe it is unsafe to use the fireplace. We recommend qualified personnel be retained to evaluate the fireplace and determine what corrective steps will need to be taken.

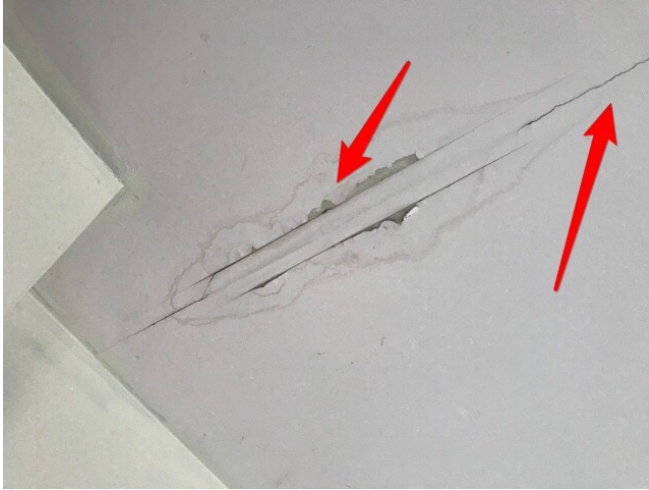
WARN The ceiling is stained, with evidence that this is an active leak. The source of the leak should be identified and necessary repairs be performed.

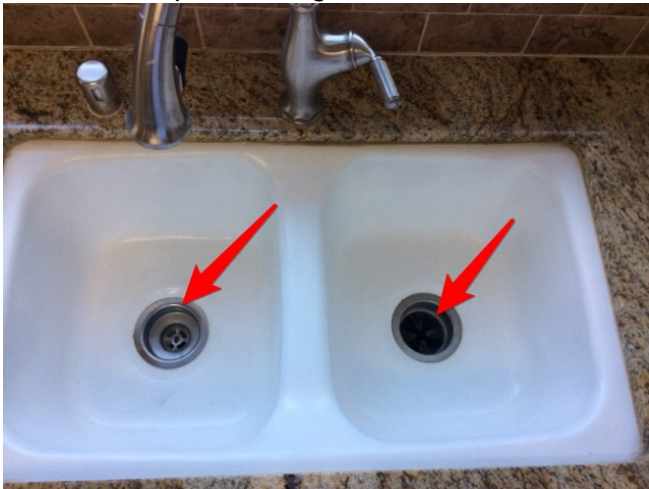
The drain stop is missing. We recommend it be replaced.

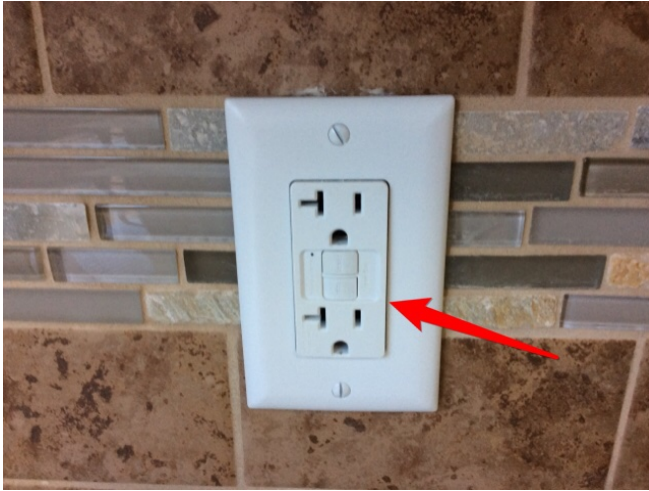
GFCI will not reset.

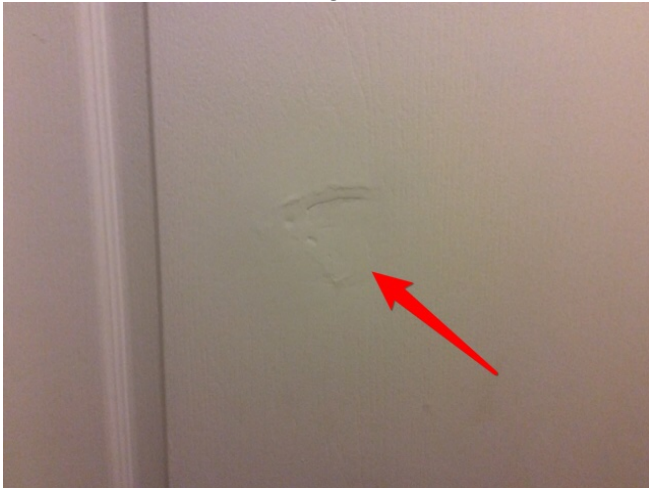
The middle door is damaged. We recommend it be repaired or replaced.

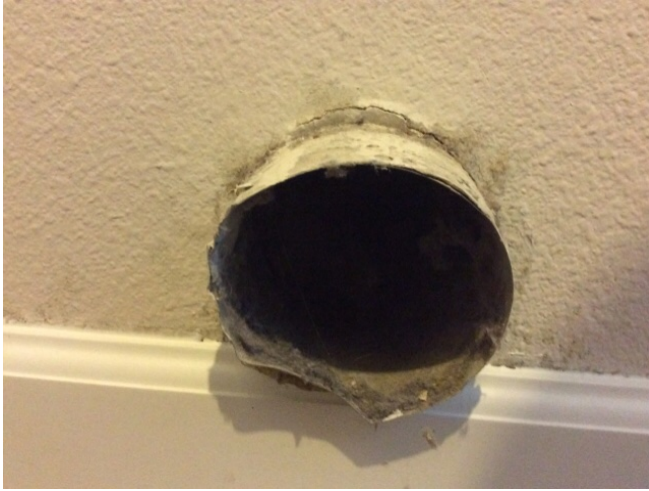
WARN The dryer vent has accumulated dirt and debris. We recommend it be cleaned.

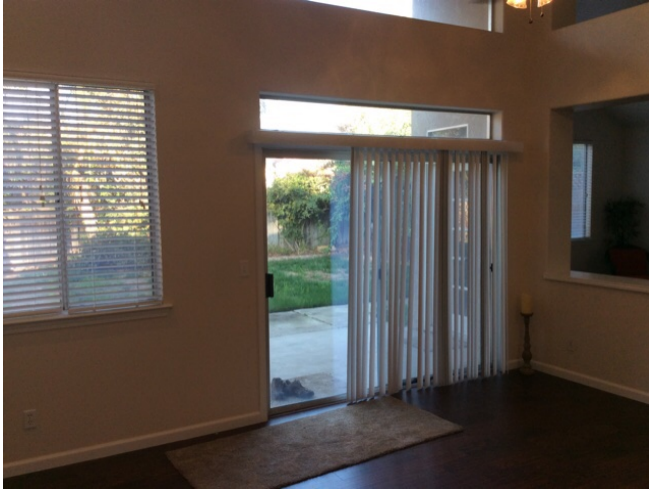
The sliding door does not operate properly, indicating the track is misaligned, dirty, or the wheels are damaged. We recommend repair or replacement.
