# **SUPERIOR HOME SOLUTIONS**

## **Home Inspection Report**

Property Address:  
8130 Westport Circle  
Discovery Bay, CA 94505

| <b>Date:</b> 10/24/2016 | <b>Time:</b> 10:00AM | <b>Report ID:</b> A29143 |

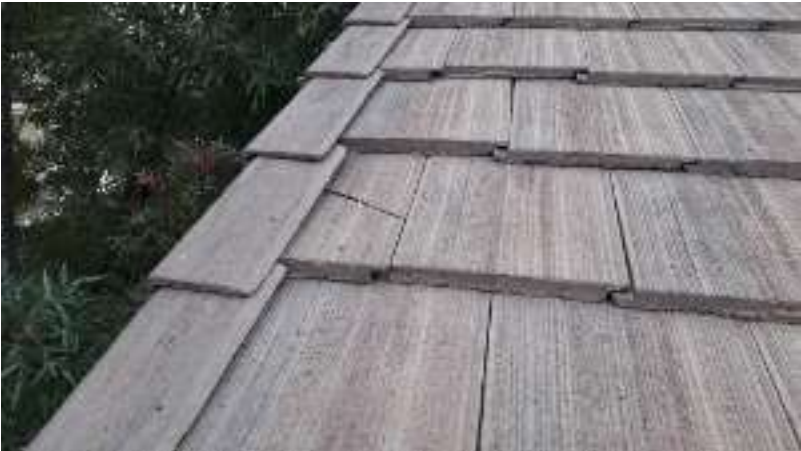
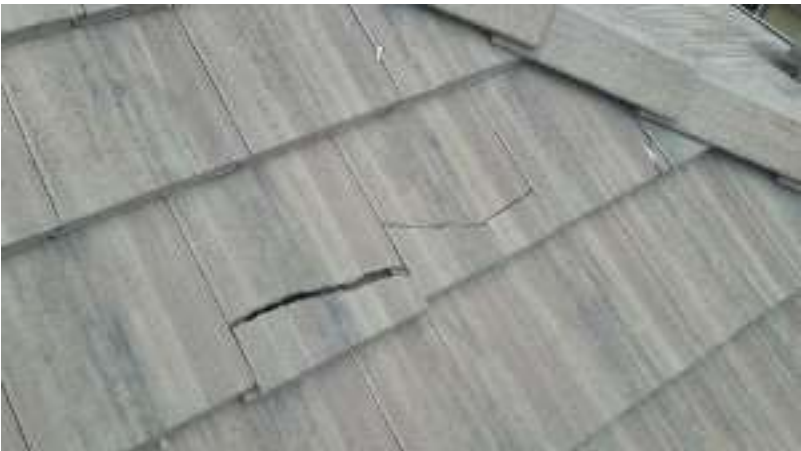
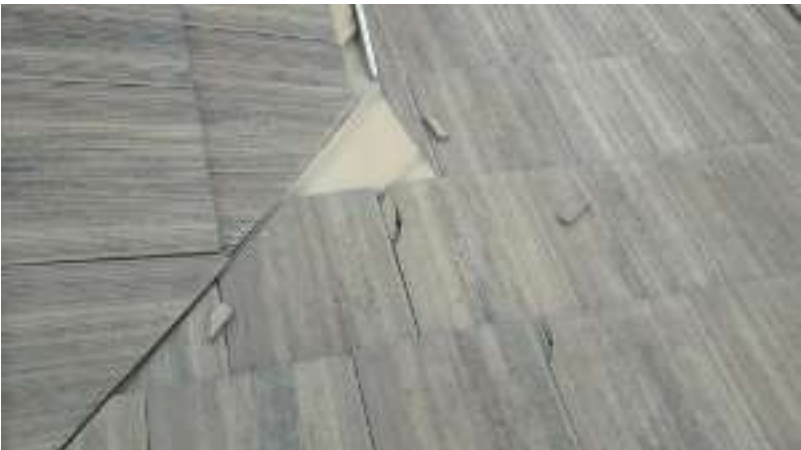
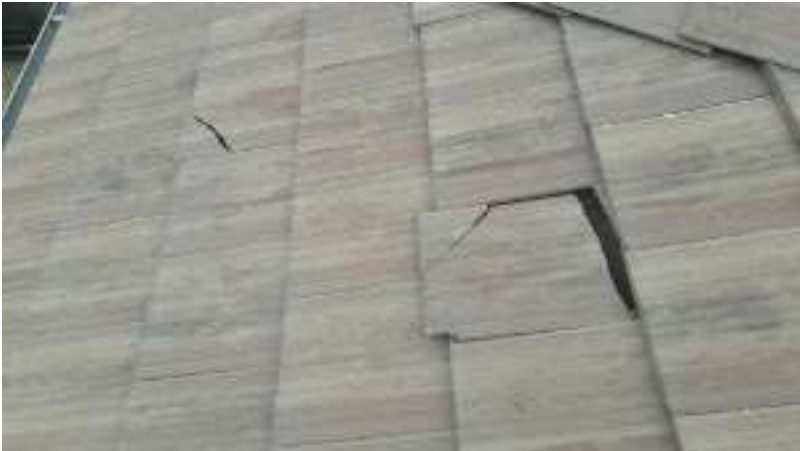
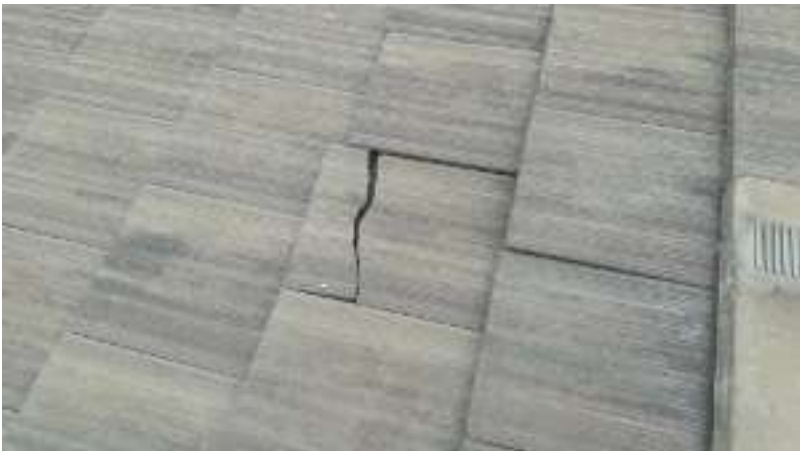
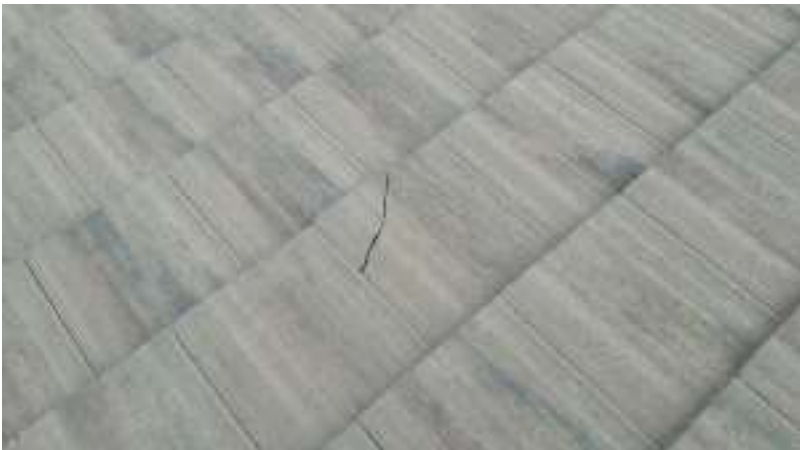
The roof covering is a concrete tile. The overall condition is described as good. The underlayment is without tears and rotted spots. Several tiles were seen cracked. See 1.0 photo 1 to 6 below. Recommend that the tiles be replaced/sealed to prevent water from affecting the underlayment.

1. The roof covering is a concrete tile. The overall condition is described as good. The underlayment is without tears and rotted spots. Several tiles were seen cracked. See 1.0 photo 1 to 6 below. Recommend that the tiles be replaced/sealed to prevent water from affecting the underlayment.

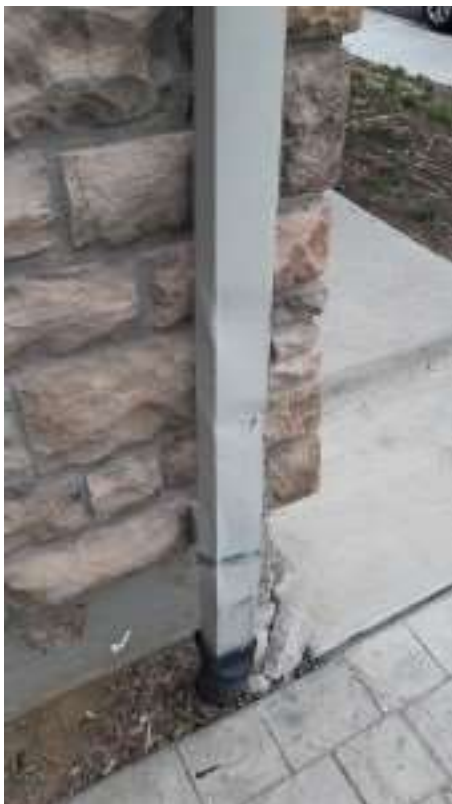
The gutter by the front porch was damaged. See 1.3 photo 1 below. Also, the gutter at the front/left corner of the house was rusted due to water exposure from the nearby pipe. See 1.3 photo 2 and 3 below. No active water leak noted at the time of the inspection. The stucco at the corner was also disintegrated as a result. See 1.3 photo 4 below.

2. The gutter by the front porch was damaged. See 1.3 photo 1 below. Also, the gutter at the front/left corner of the house was rusted due to water exposure from the nearby pipe. See 1.3 photo 2 and 3 below. No active water leak noted at the time of the inspection. The stucco at the corner was also disintegrated as a result. See 1.3 photo 4 below.

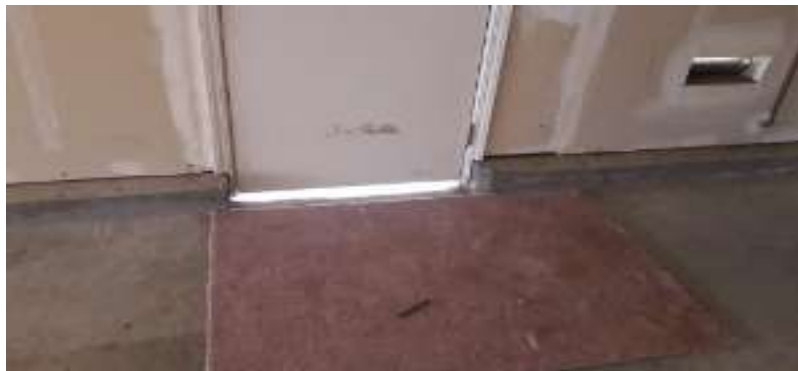
The side garage door had a wide gap at the bottom. Recommend that a weather strip be installed. See 2.1 photo 1 below.

3. The side garage door had a wide gap at the bottom. Recommend that a weather strip be installed. See 2.1 photo 1 below.
4. Extensive tree roots were seen on the front lawn of the house. See 2.4 photo 1 below.

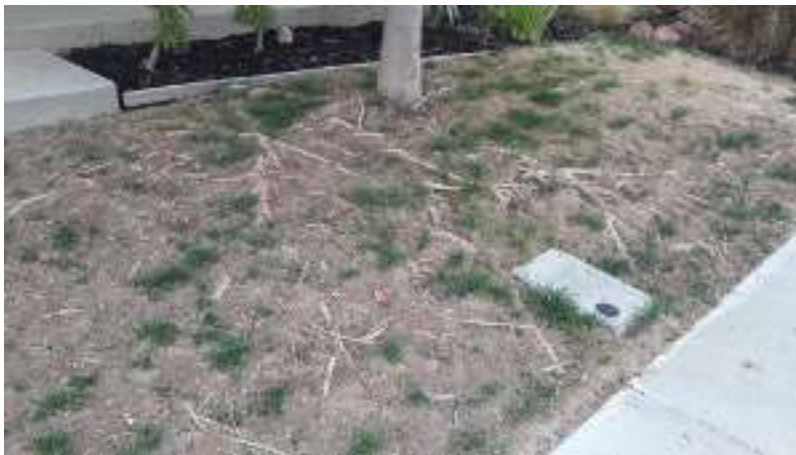
Extensive tree roots were seen on the front lawn of the house. See 2.4 photo 1 below.

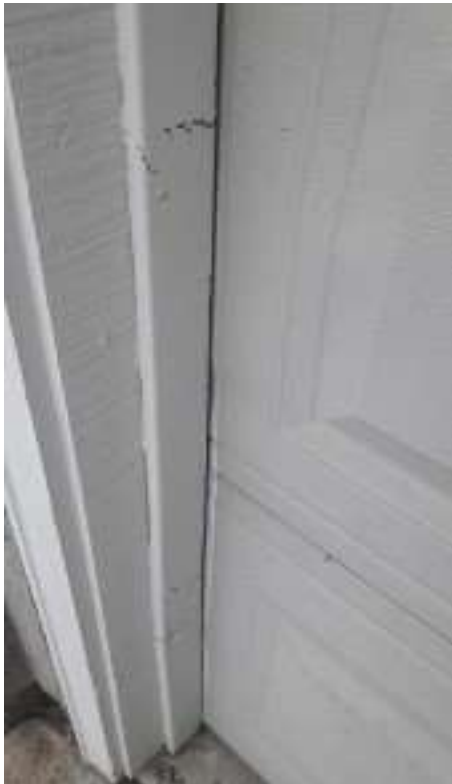
A dent was seen at the corner of the aluminum garage and the exterior molding was cracked. See 3.3 photo 1 below.

5. A dent was seen at the corner of the aluminum garage and the exterior molding was cracked. See 3.3 photo 1 below.

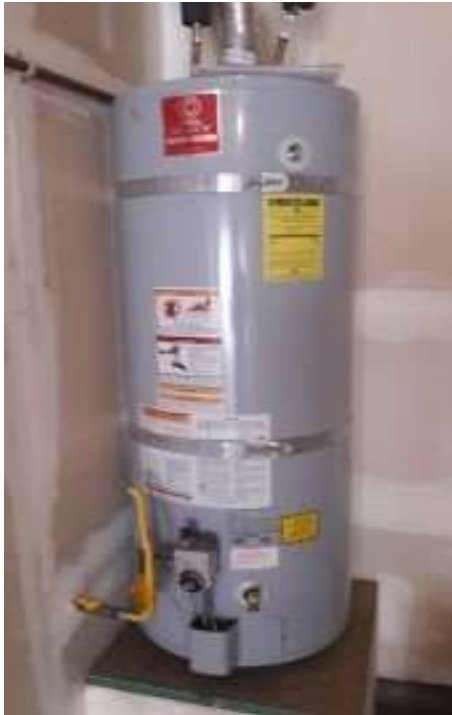
The water heating unit is in the garage. The unit is operational. No leaks were noted. The hot and cold water inlet are both operational. The drain valve is intact. The gas line is properly attached without any corrosion. The heating element is okay. The heating/cooling drain pipes are operational. No leak or calcification noted on any of the galvanized or copper piping. See 6.1 photo 1 below.
