PROPERTY INSPECTION REPORT

3692 Calafia Avenue, Oakland, CA 94605

Date of Inspection: 12/4/2019 Time: 0930

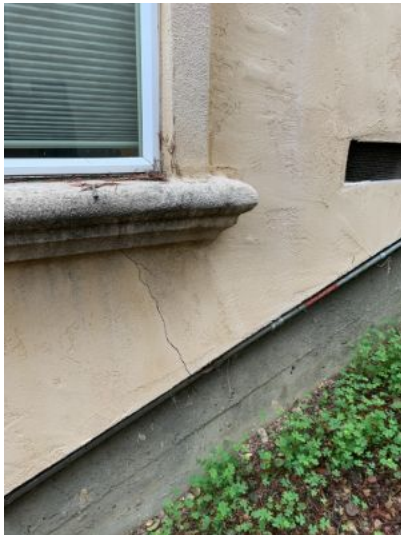
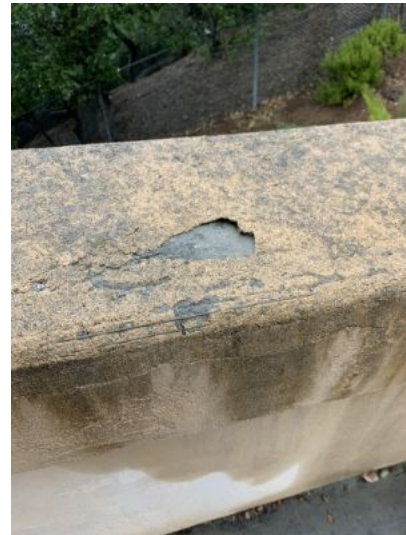
2. Siding Conditions

- There are cracks in the stucco siding located at various areas around the structure. This is common and it isn't significant to the structure or to the possibility of moisture intrusion. However, those that can be sealed, should be sealed to prevent deterioration to the stucco.
- **The stucco wall at the driveway should be repaired to prevent moisture intrusion.**

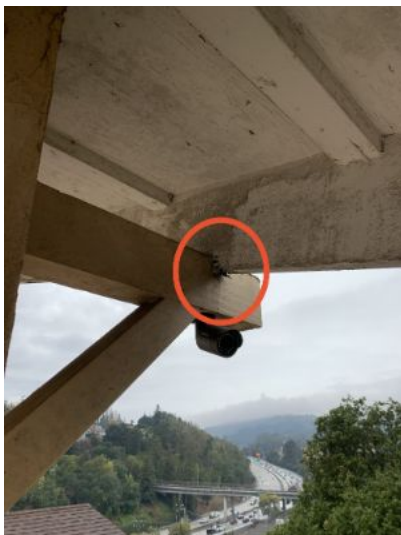
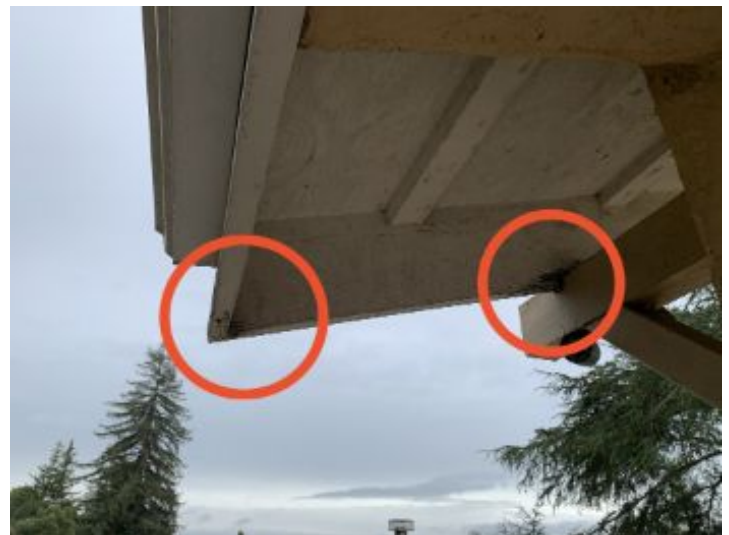
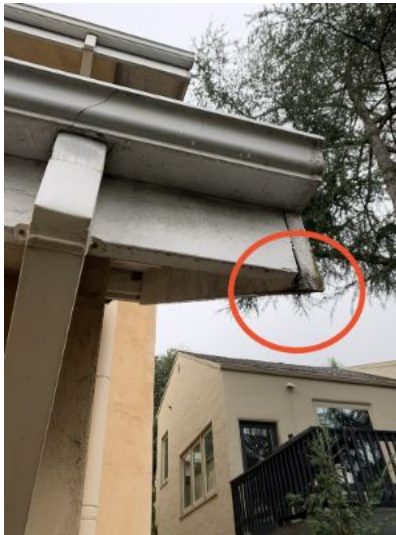
3. Eave and Fascia Condition

- Water damage is present at a barge rafter located at the front of the structure. The termite report (if one was ordered) is very specific as to the location of the damage and recommendations. However, this will need repair or replacement.

- Water damage is present at a barge rafter and fascia located at the left front corner of the structure. The termite report (if one was ordered) is very specific as to the location of the damage and recommendations. However, this will need repair or replacement.

- Water damage is present at a barge rafter located at the right front corner of the structure. The termite report (if one was ordered) is very specific as to the location of the damage and recommendations. However, this will need repair or replacement.

- Water damage is present at a barge rafter located at the left rear corner of the structure. The termite report (if one was ordered) is very specific as to the location of the damage and recommendations. However, this will need repair or replacement.

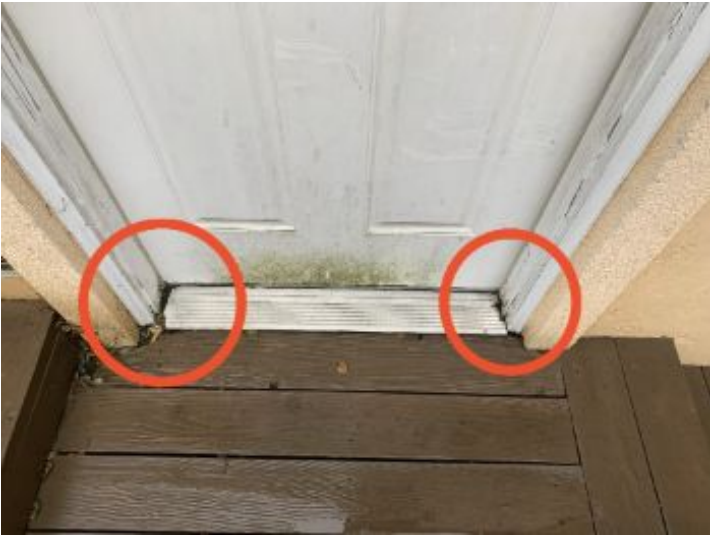
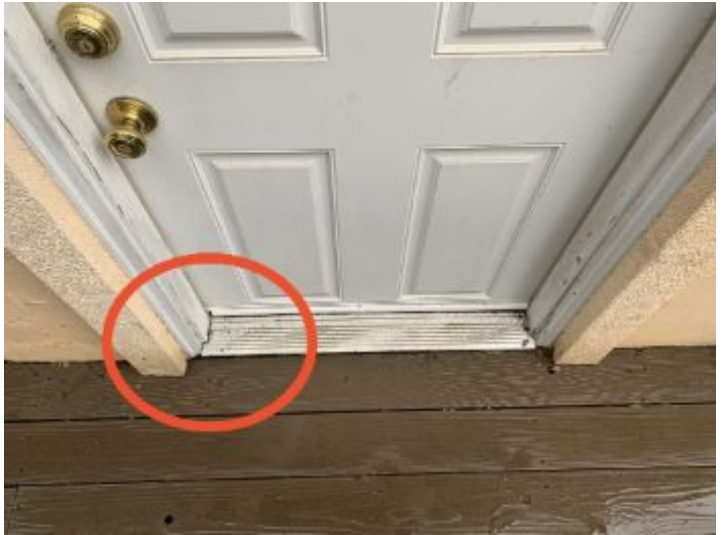
5. Exterior Door Condition

Observations:
 • The front door is in acceptable condition.
 • The security screen door is in acceptable condition.
 • Water damage is present at the door jambs at the front of the structure. We recommend the services of a qualified and licensed contractor for the repair or replacement of this finding.
 • Water damage is present at a door jamb at the right rear corner of the structure. We recommend the services of a qualified and licensed contractor for the repair or replacement of this finding.

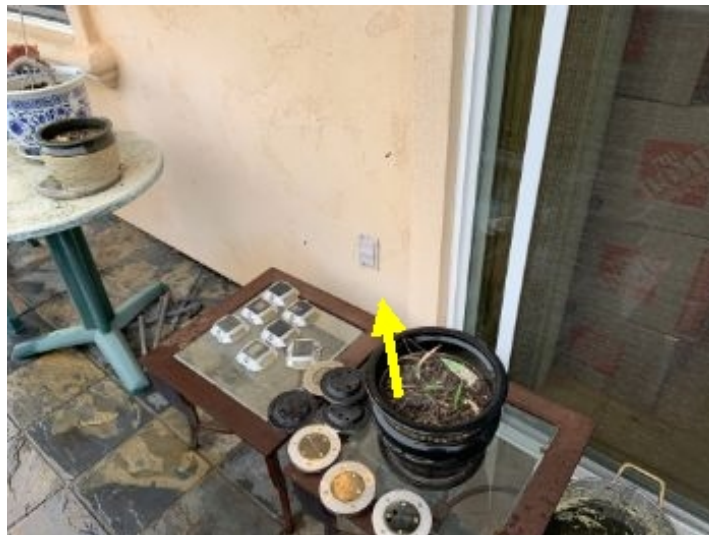
8. Outlet Conditions

- Safety Issue - The ground fault circuit interrupter wouldn't trip and will probably need replacement at the balcony.**

The approximate cost for the replacement would be between \$75 – \$125 per outlet.

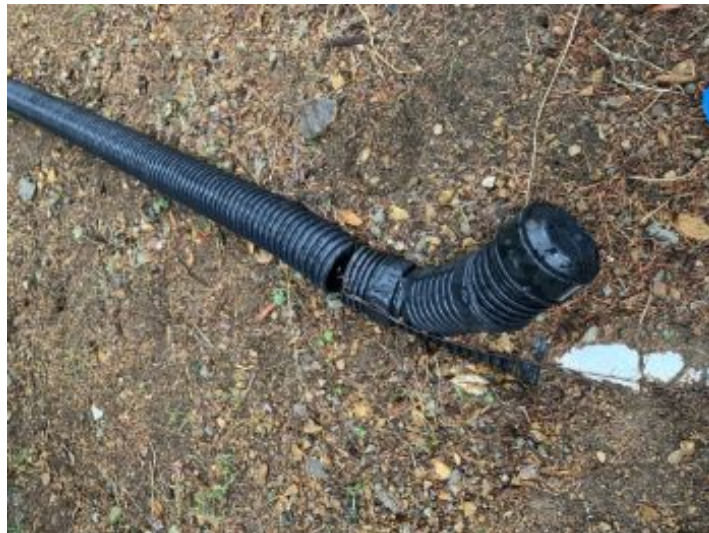
3. Condition of Drainage

- Drainage: hard surfaces, percolation, partial or full gutter system, with tie-in drains.
- The gutters are filled with detritus. This will need to be cleaned out to prevent water damage to the eaves and premature rusting. We also recommend the installation of gutter screens to keep the debris out. They cost between \$1.50 - \$2.50 per linear foot if you install them.
- A corrugated drain pipe connection at the left rear corner of the structure to a downspout has damaged to the point that it is facilitating the introduction of debris through the damaged openings. It can also lead to erosion around the footing of the foundation.

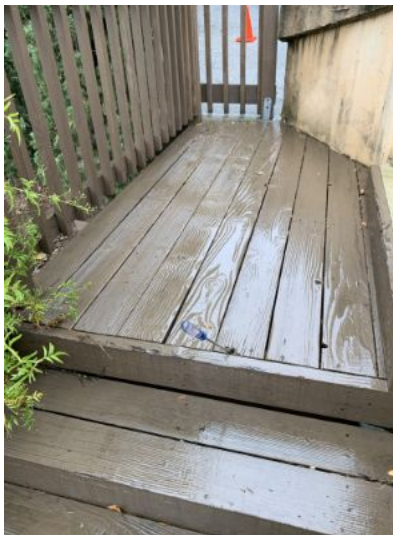
5. Deck Conditions

- What can be seen of the deck is in acceptable condition.
- Maintenance – Whether treated or not, it is important to keep a wood deck surface free of all forms of fungal growth and debris that retains moisture and will cause the deck to eventually rot. Recommend cleaning and resealing the deck annually. Cleaning can be accomplished by scrubbing the deck with a sodium-hypochlorite (bleach) and Tri-Sodium-Phosphate (TSP) deck wash and then rinsing with a pressure washer. Finally, a wood deck should be recoated with a good-quality deck sealant.
- The sides of the deck have skirting. This makes the underside of the deck and inaccessible area as this is a visual inspection. As a result of this, I can't comment on the condition of the framing members below the deck planks.
- **Water damage is present at a deck plank which should be replaced by a qualified and licensed contractor.**

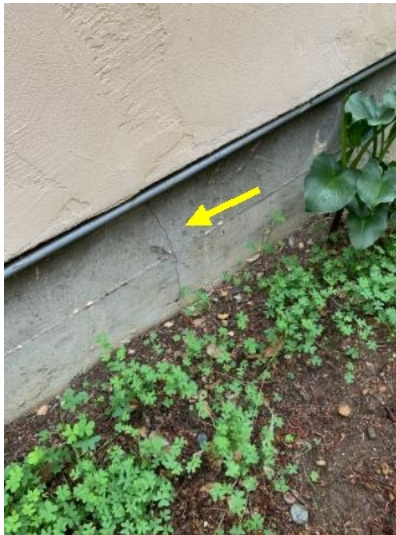
2. Foundations

- What can be seen of the foundation is in acceptable condition.
- There are a few minor cracks that have occurred over the years which don't have any impact or ongoing significance to the structure of the home. This is a relatively common condition that occurs during the curing process and is normally no reason for concern.

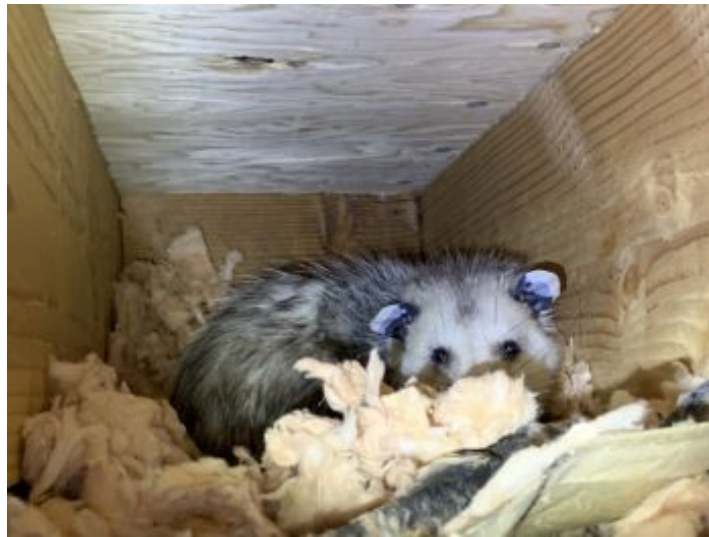
3. Crawlspace

- A live opossum was observed in the lower crawlspace. This should be evaluated by a licensed branch two pest control specialist.

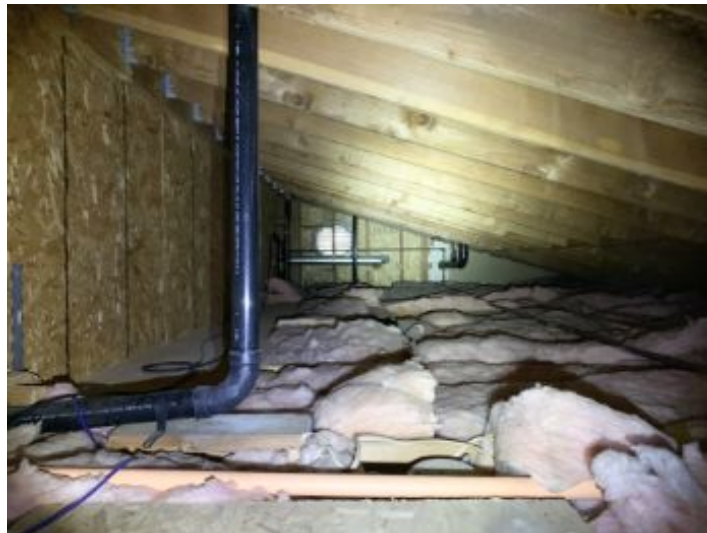
- Insulated Attic - I performed a visual inspection from the access opening only, under limited lighting conditions. Therefore, the attic was not fully inspected due to insulation covering the lower wood members of the attic. For this reason, defects may be discovered at a later date.

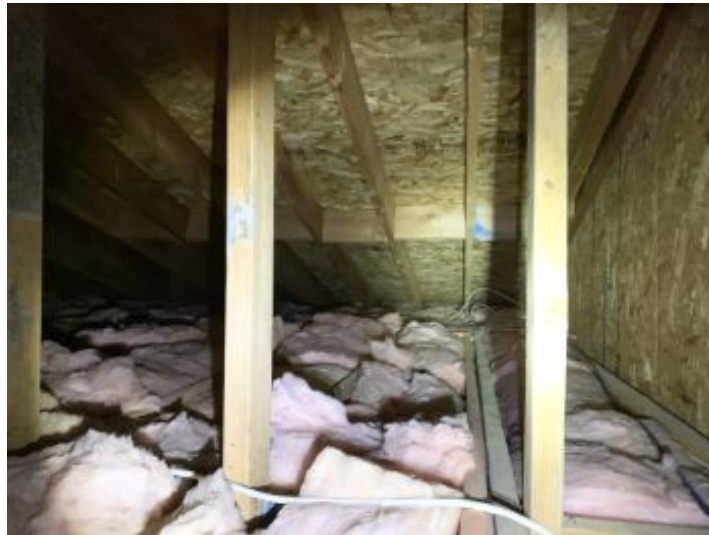
2. Attic Framing Condition

- The visible portions of the framing are in acceptable condition, and would conform to the standards of the year in which they were constructed.

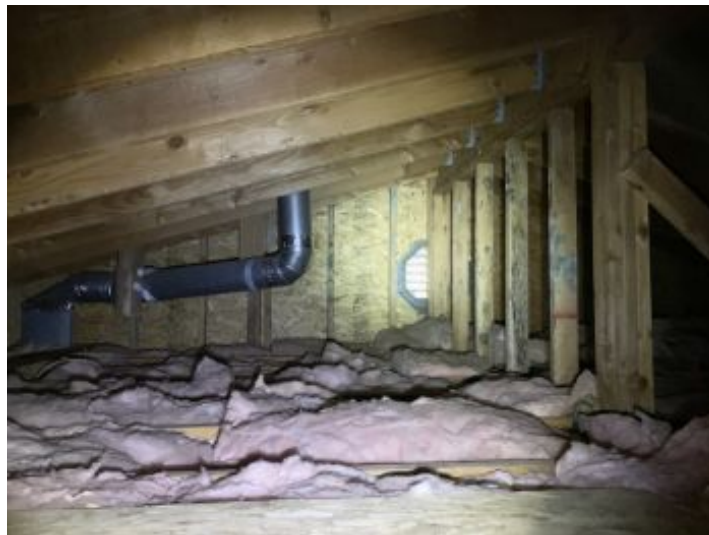
- What can be see of the insulation from the opening in limited lighting, is in acceptable condition. There are areas that were inaccessible for inspection.
- The attic area(s) are insulated with one or more of the following materials:
 - *Fiberglass batts.
 - *Insulation averages about 12-14 inches in depth

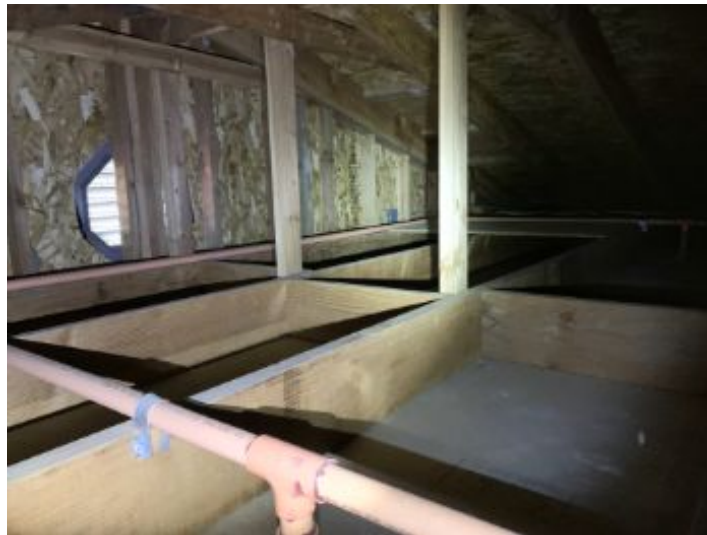
- Uninsulated Attic - I performed a visual inspection from the access opening only, under limited lighting conditions. Therefore, the attic was not fully inspected due to the possibility of damaging the sheetrock or plaster ceiling. For this reason, defects may be discovered at a later date.

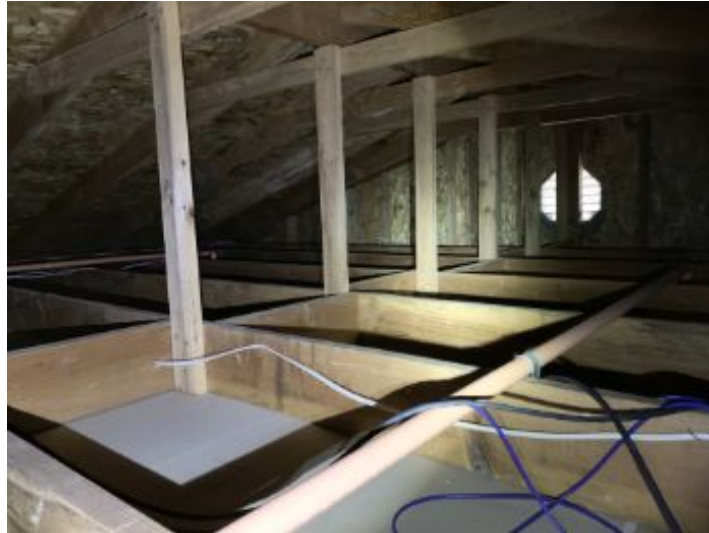
2. Attic Framing Condition

- The visible portions of the framing are in acceptable condition, and would conform to the standards of the year in which they were constructed.

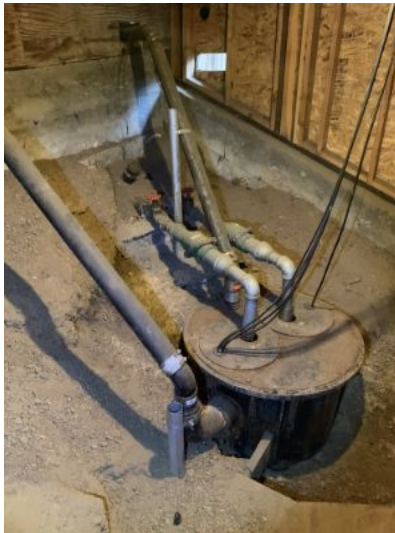
- The sewage assist pump was serviceable at the time of the inspection.

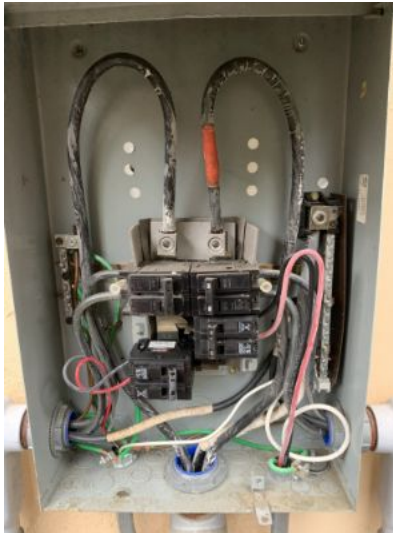
- The main service panel is 100 amps.
- The main electrical service panel is located at the right rear corner of the structure.
- The wiring is composed of modern Romex conduit.
- The means of grounding is by UFER (rebar, encased in concrete).
- There is a photovoltaic solar system installed on the structure. We don't inspect these components and so we recommend a further inspection by a qualified and licensed contractor that specializes in these systems.

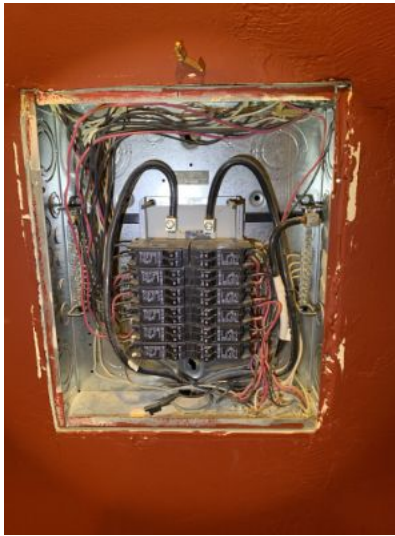
- The distribution remote panel is located in the hallway.
- The wiring is composed of modern Romex conduit.
- The distribution panel remotes are commonly located inside residences, but not always. However, they are required to be weatherproof, unobstructed, and easily accessible, and their circuits should be clearly labeled. When the size of the panel is mentioned, it is referring to the maximum amount of amperage that the panels can accommodate. It is not referring to the amount of amperage currently available in the panel.
- Most of the wiring in the residence is in enclosed and inaccessible areas and so we can't give a blanket comment as to the condition of the system.

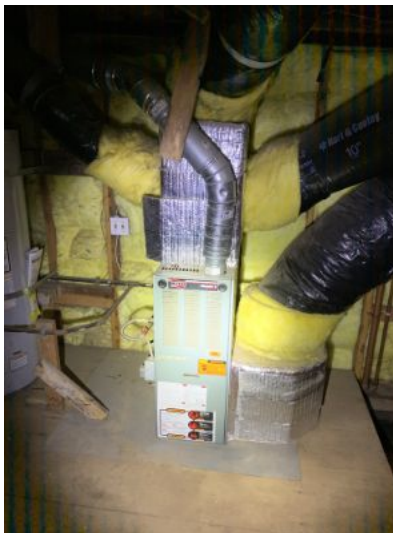
- Have the system, including the cabinet, burners, blower and filter cleaned and adjusted on an appropriate schedule. You can determine what constitutes an appropriate schedule by consulting with a qualified heating contractor.
- Furnace was functional at the time of the inspection; the burner flames were a healthy blue.

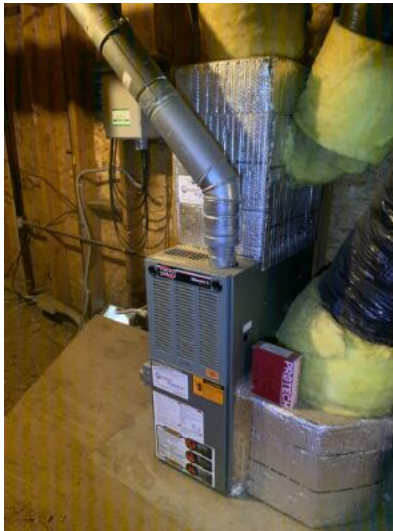
- Have the system, including the cabinet, burners, blower and filter cleaned and adjusted on an appropriate schedule. You can determine what constitutes an appropriate schedule by consulting with a qualified heating contractor.
- Furnace was functional at the time of the inspection; the burner flames were a healthy blue.

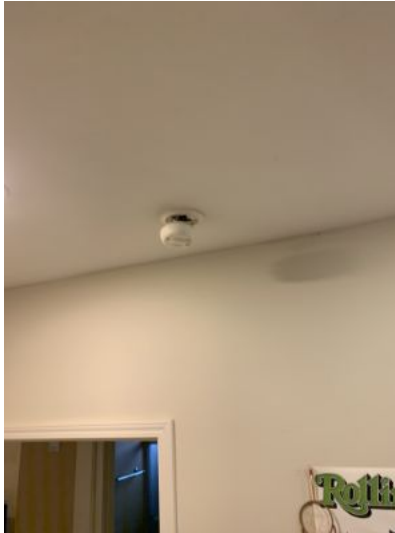
- The smoke detectors are in acceptable condition.
- A smoke detector is hanging by the wiring at the right middle bedroom.

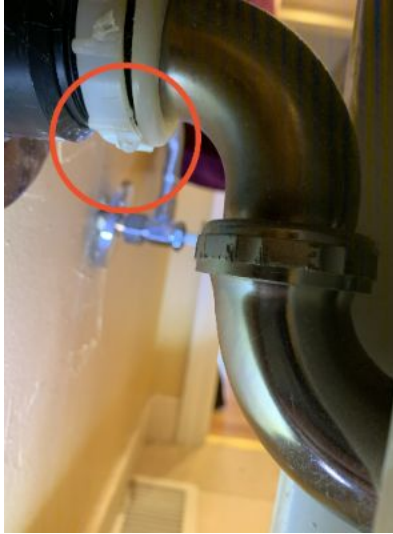
- The drain line leaks under the sink in the half bathroom. I recommend the services of a qualified, licensed plumber for the evaluation and repair or replacement of the aforementioned item(s).

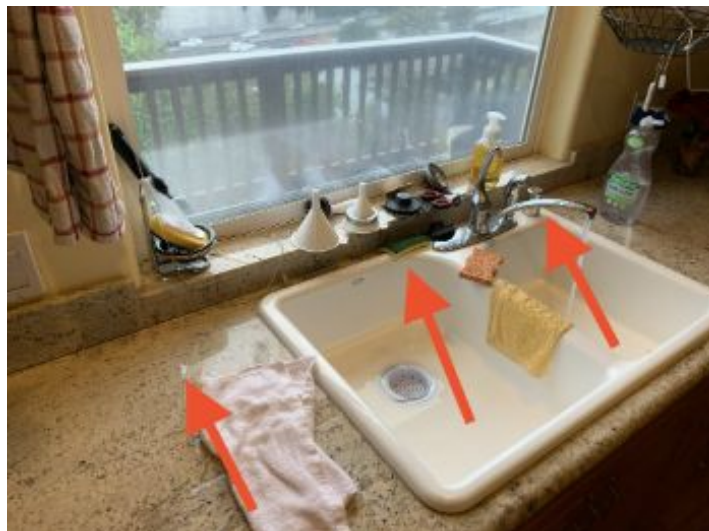
- The cabinets and counter tops are in acceptable condition.
- Re-grouting is necessary between the counter and the backsplash to keep moisture causing damage to the wood framing.
