## Roof Inspection Report

**1635 Clearview Drive, San Leandro**

Kane Howell  
May 21, 2020  
Reg No. 121052 SP

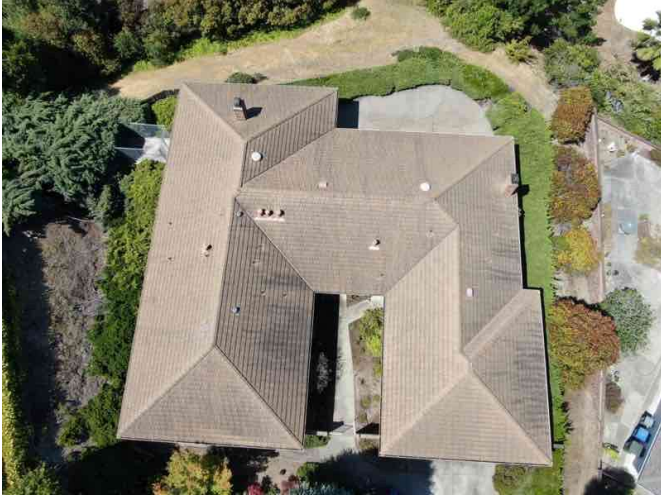
Photo 01

1. Birds eye view (See Photo 1) (See Photo 2) (See Photo 3)
2. General roof photos: (See Photo 4) (See Photo 5) (See Photo 6)
3. The chimney counter flashing requires sealing. (See Photo 7) (See Photo 8) (See Photo 9)
4. Debris is impeding water travel at the valley. (See Photo 10)
5. During the course of the inspection we noted broken ridge tile(s). (See Photo 11)
6. During the course of this inspection we noted broken field tile(s). (See Photo 12)
