SUPERIOR HOME SOLUTIONS

Home Inspection Report

Property Address:
2370 Scout Street
Oakland, CA 94611

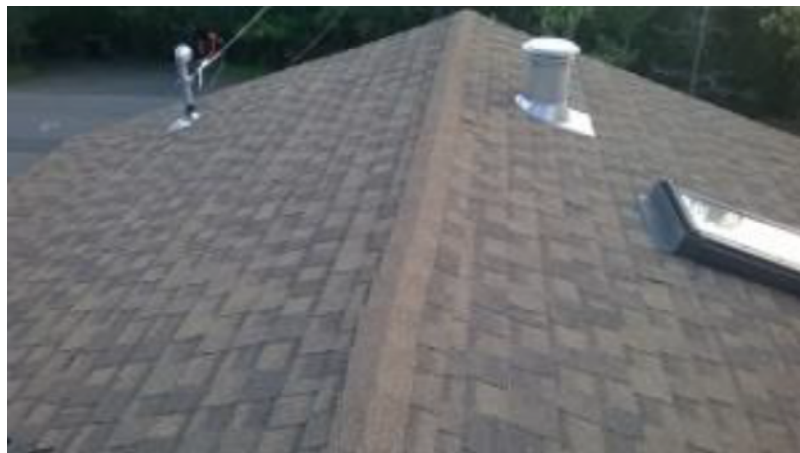
1.0 photo 4

The roof covering is an Architectural Composition Shingles. The overall condition is described as good. The underlayment is without tears and rotted spots. No active water intrusion noted through the shingles. See 1.0 photo 1 to 3 below.
