Confidential Inspection Report

LOCATED AT:
6026 W Fir Ave
, California

INSPECTED ON:
Wednesday, November 22, 2017

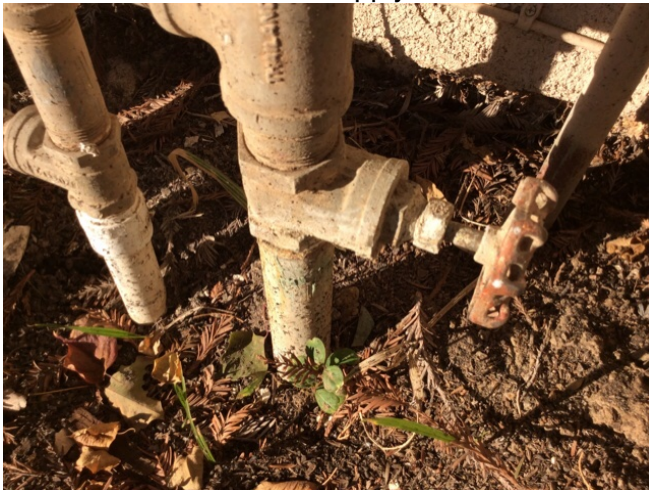
WATER SHUTOFF LOCATION

The domestic water supply main shut-off valve is outside at the front of the building.

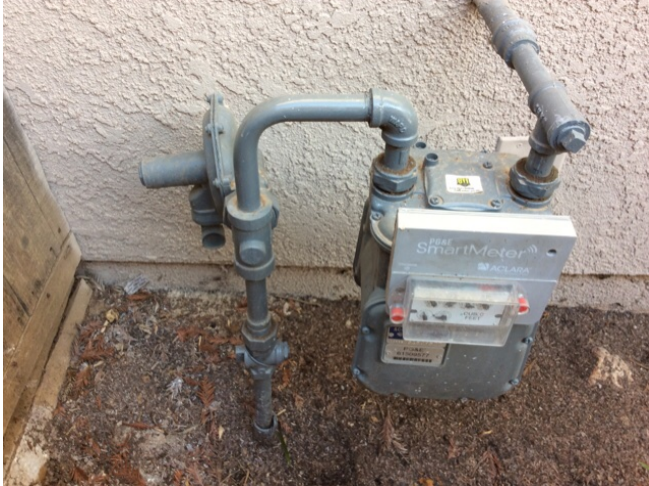
GAS METER LOCATION

The gas meter is outside on the left side of the building. The main gas supply shutoff valve is located on the riser pipe between the ground and the meter. This valve should be turned 90 degrees (either way) in order to shut off the gas.

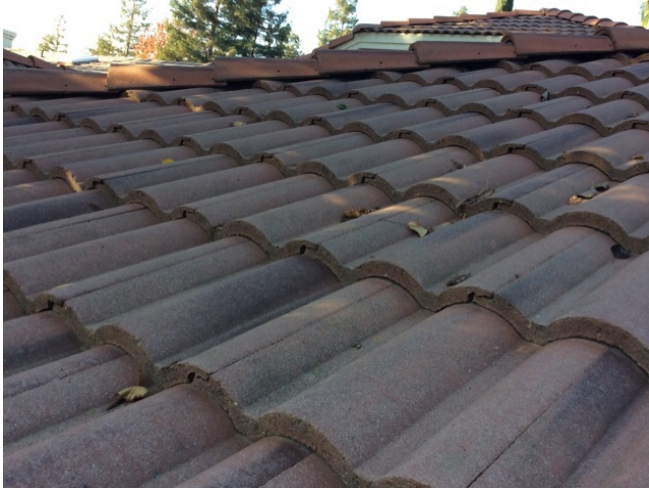
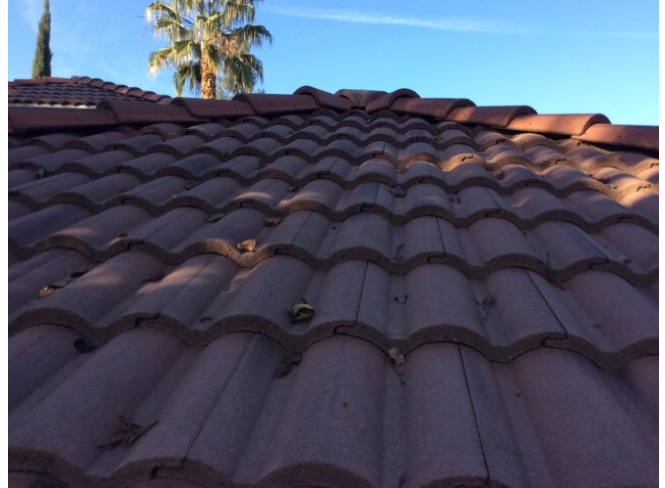
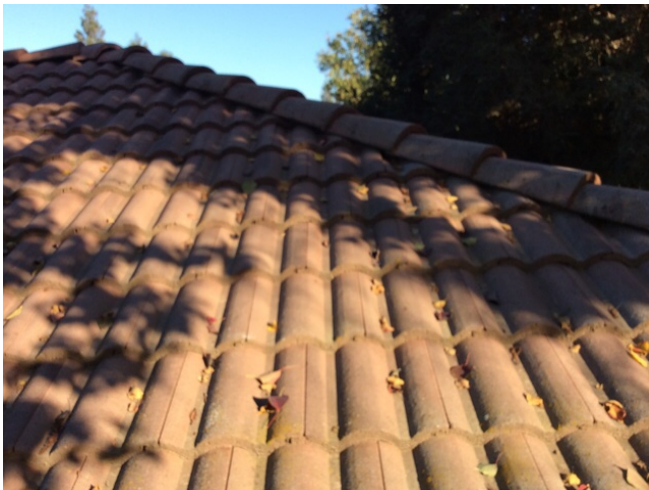
We inspected this roof from the edge of the surfaces. Walking on the roof was judged to be potentially hazardous for the inspector and/or potentially damaging to the surface materials. We have based our comments upon a limited inspection.

WARN There is debris on the roof, requiring removal to prevent accelerated deterioration of the membrane under the tiles. We recommend that the roof be monitored and periodically cleared of debris in the course of routine property maintenance.

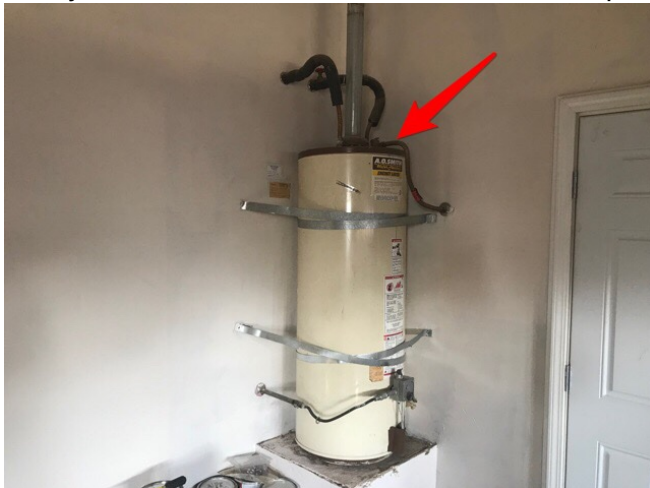
T/P RELEASE VALVE

The water heater is equipped with a temperature and pressure relief valve. This device is an important safety device and should not be altered or tampered with. We observed no adverse conditions.

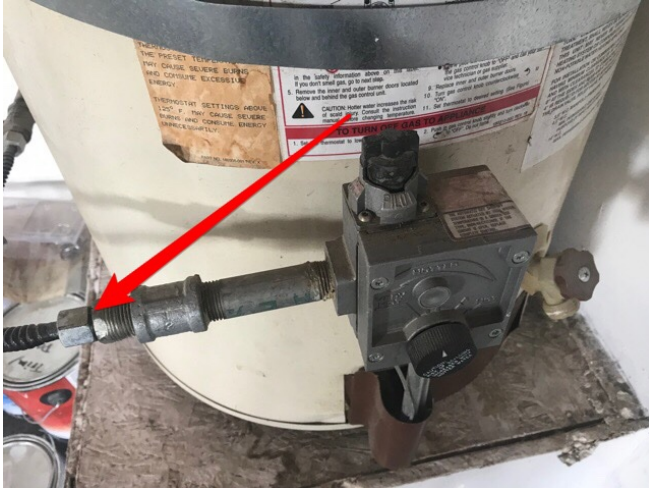
GAS SUPPLY

The gas piping for the appliance includes a local 90 degree shut-off valve for use in an emergency or in case of repair. The valve was not tested at the time of inspection, but is of a type usually found to be serviceable.

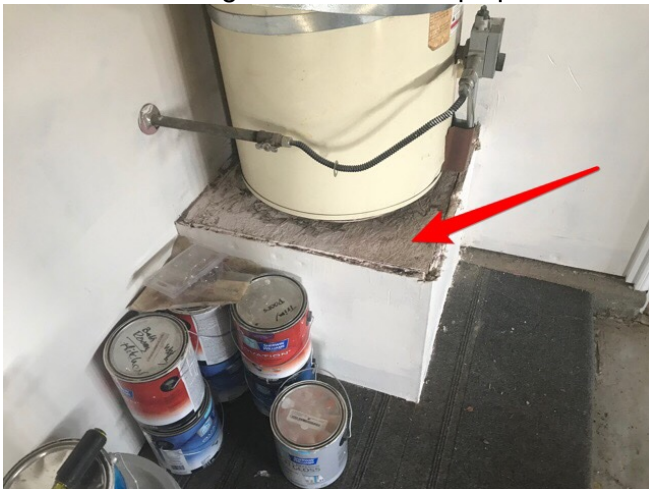
ELEVATION/LOCATION

The water heater has been elevated above the garage floor in accordance with present standards. This is a beneficial configuration which helps prevent the ignition of fumes from spilled flammable liquids.

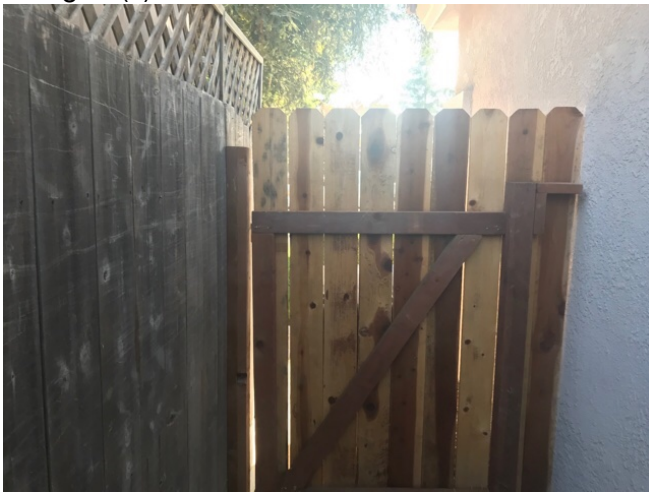
GATES

The gate(s) is/are locked and/or were inaccessible for inspection. We recommend further review.

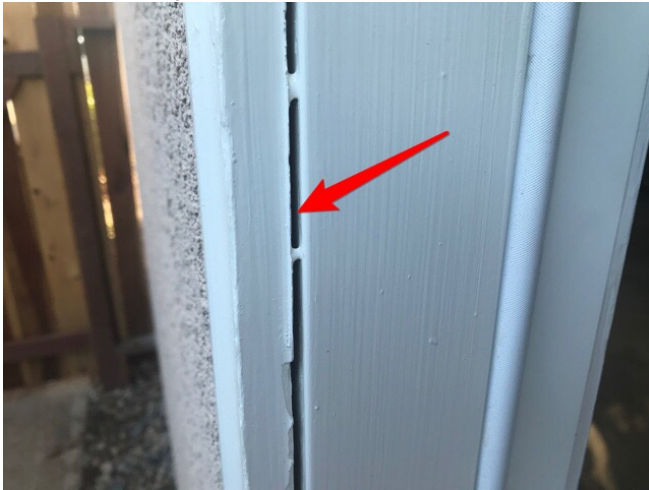
GENERAL COMMENT

WARN As preventive maintenance, caulking and sealing the gaps in the exterior of the building around the doors, windows, plumbing and electrical entry points will help prevent heat loss, cold air infiltration and moisture entry.

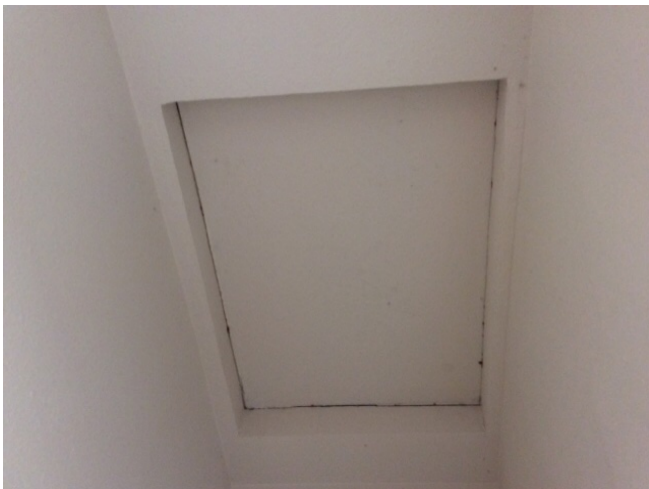
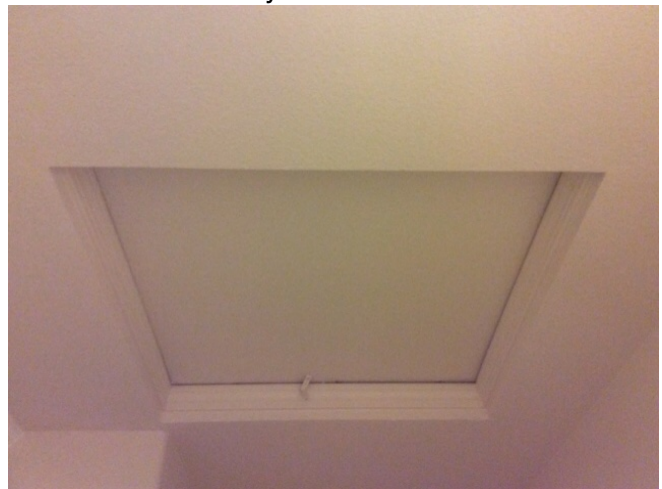
ACCESS/ENTRY

WARN Attic access hatches are located in the front bedroom and the Laundry room.

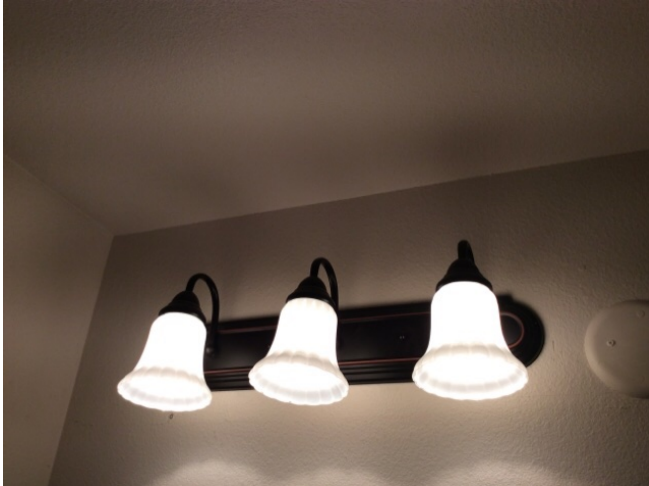
Lights are working at this time.

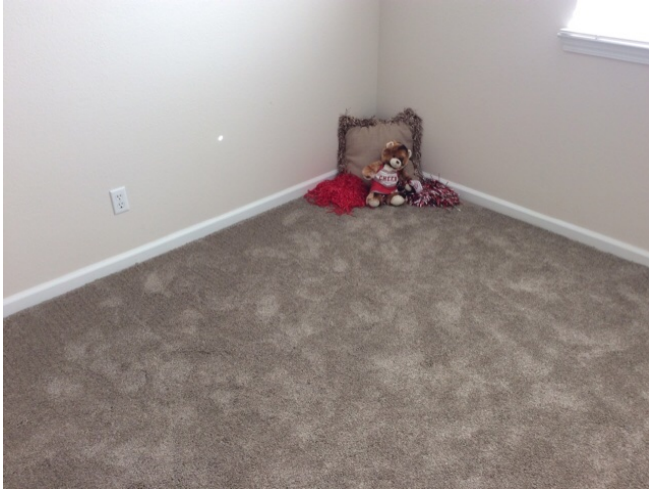
FLOOR

The floors are covered with wall-to-wall carpet. No attempt was made to determine the type or condition of the material under the carpet.

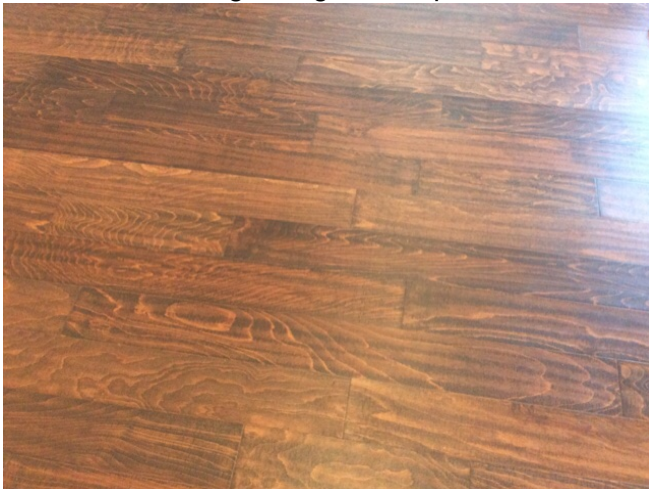
FLOOR

New wood flooring is in good shape at this time.

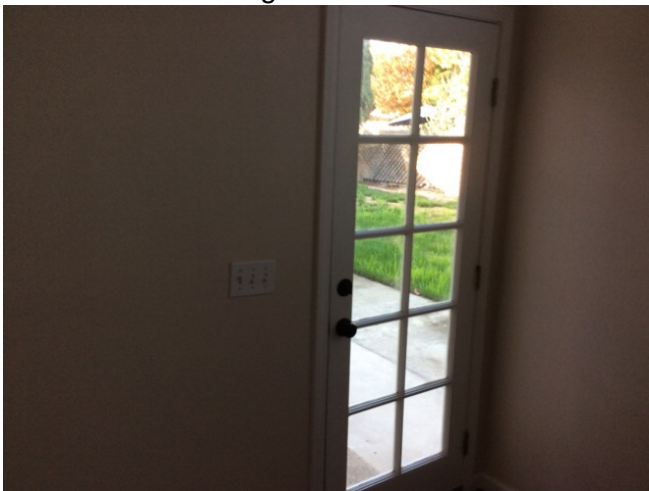
DOORS

All doors are working at this time.

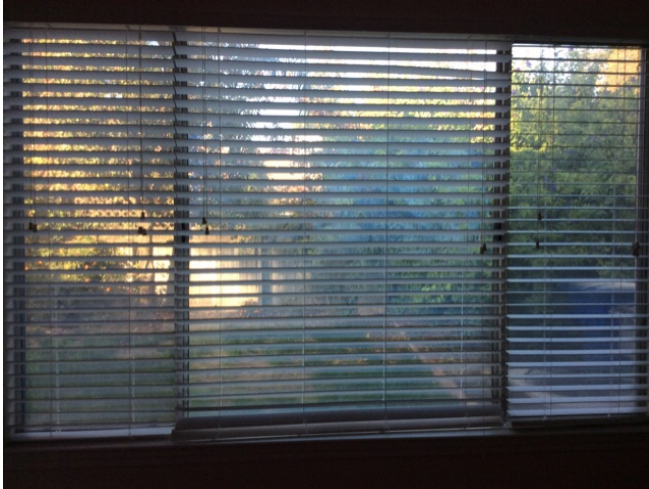
WINDOWS

The window was in operating condition. There is minor wear and tear to the track and slides. This can be improved with cleaning and lubrication.

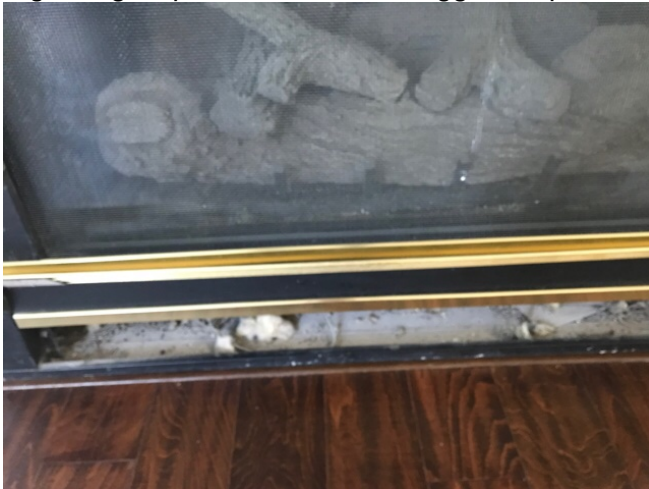
FIREPLACE

WARN The fireplace appears to be properly installed and in serviceable condition with no signs of excessive or unusual wear.

We believe it is unsafe to use the fireplace. We recommend qualified personnel be retained to evaluate the fireplace and determine what corrective steps will need to be taken.

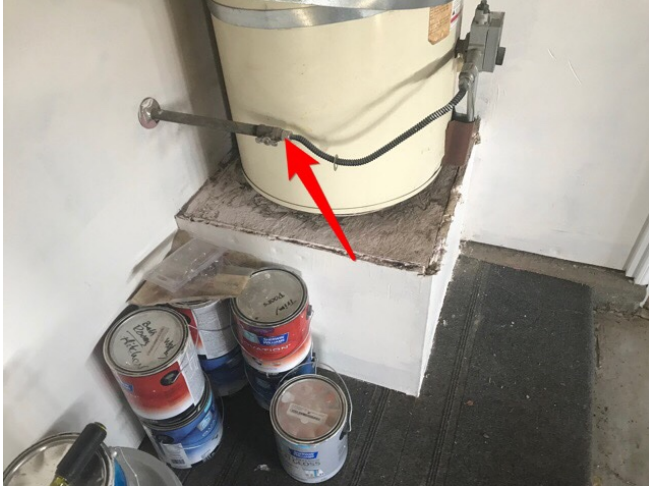
GAS SUPPLY

The gas piping for the appliance includes a local 90 degree shut-off valve for use in an emergency or in case of repair. The valve was not tested at the time of inspection, but is of a type usually found to be serviceable.

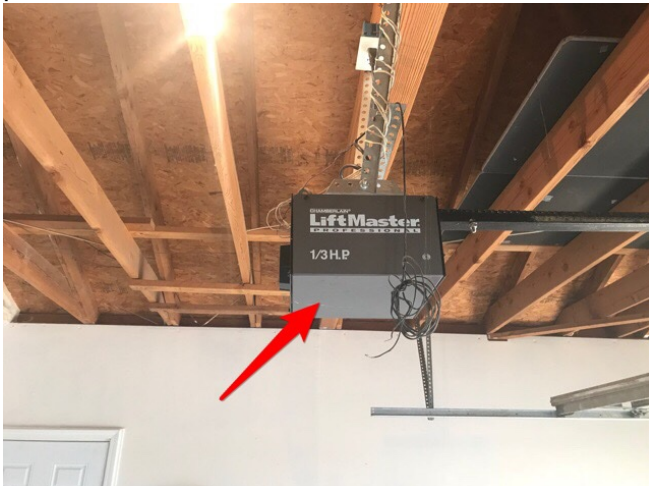
GARAGE DOOR OPENER

The garage door opener(s) operated properly to raise and lower the doors, including the auto-reverse mechanisms, which stopped and reversed the direction of the doors when they struck objects in their path.

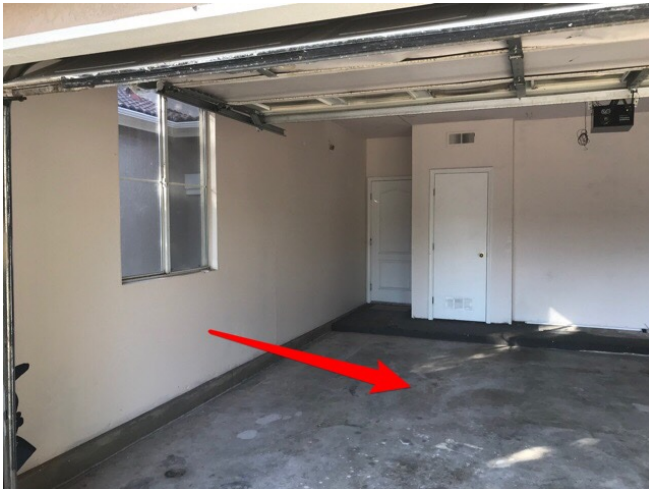
FLOOR

The floor is a concrete slab.

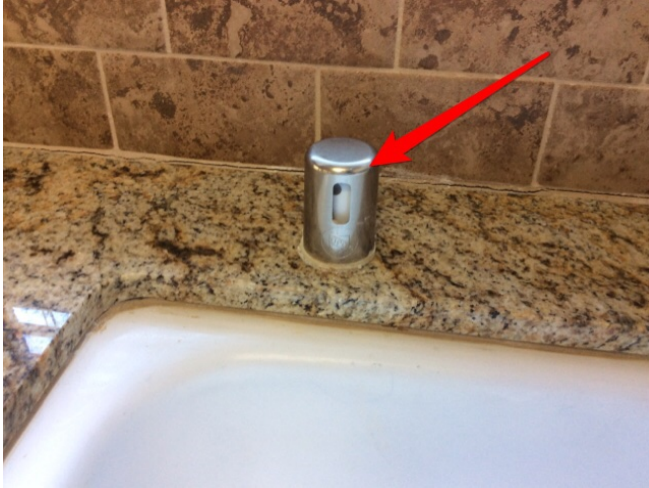
The dishwasher drain is equipped with an air-gap fitting (the cylinder protruding above the sink). This assures separation of the supply water from the waste water.

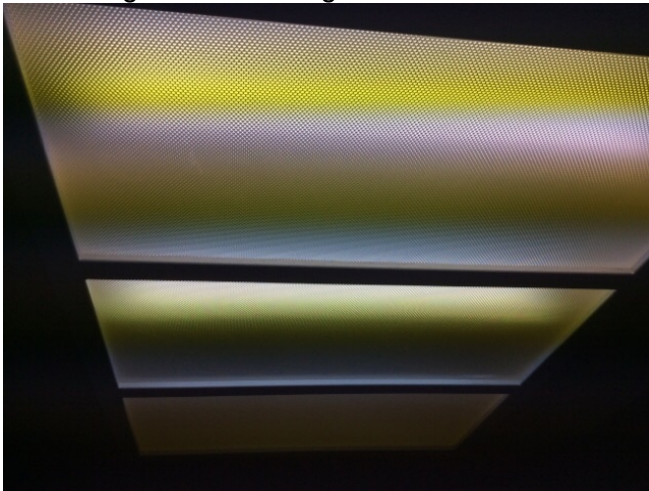
LIGHTS

Kitchen lights are working at this time.

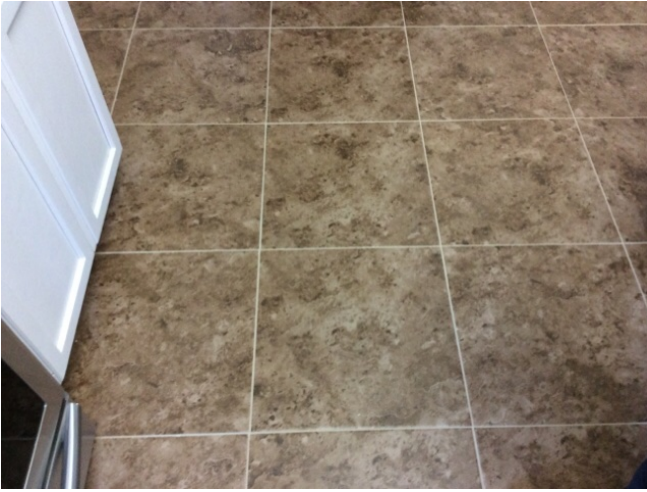
FLOOR

Tile good shape at this time.

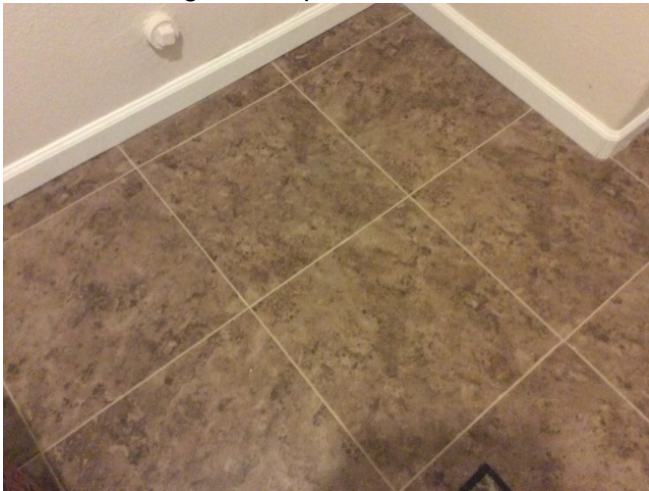
FLOOR

Tile floor is in good shape at this time.

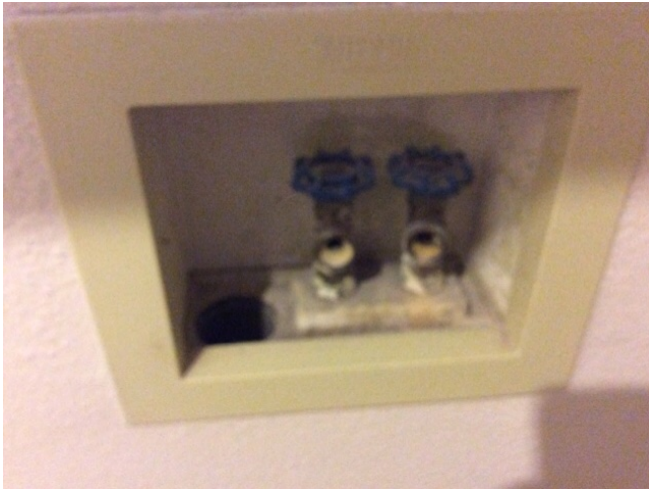
WASHER/DRYER

The hookups for the washer and dryer are properly installed and in serviceable condition. The appliances themselves were not tested.

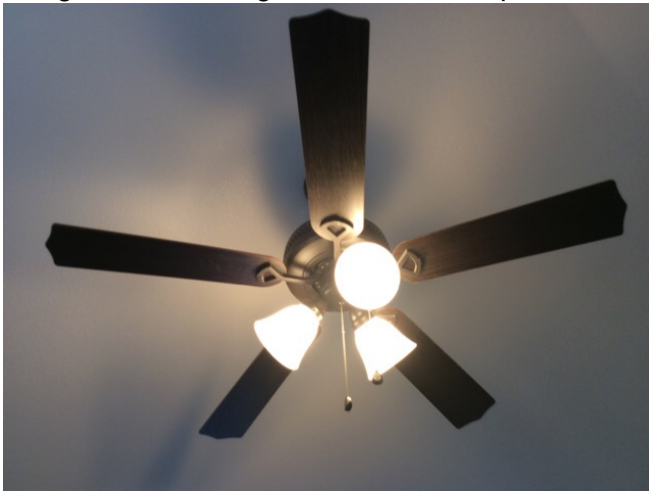
LIGHTS

All lights are working at this time of inspection.

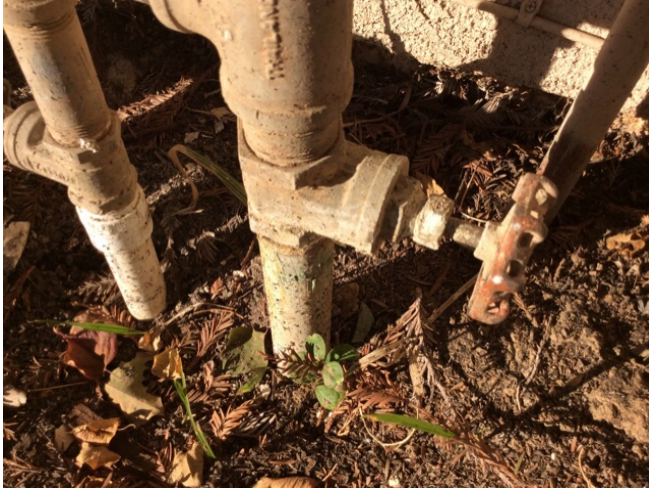
The domestic water supply main shut-off valve is outside at the front of the building.

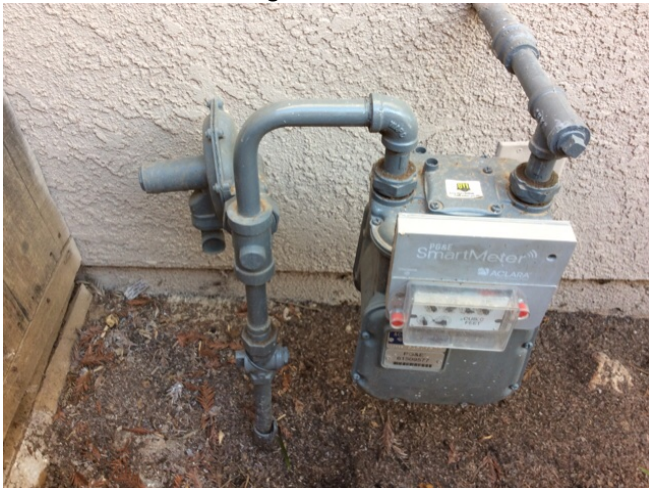
The gas meter is outside on the left side of the building. The main gas supply shutoff valve is located on the riser pipe between the ground and the meter. This valve should be turned 90 degrees (either way) in order to shut off the gas.
