WOOD DESTROYING PESTS AND ORGANISMS INSPECTION REPORT

| 5318 | MANILA AVENUE, OAKLAND CA 94618 | 7/22/2019 | 9 |

EAST BAY STRUCTURAL & TERMITE CO. INC.

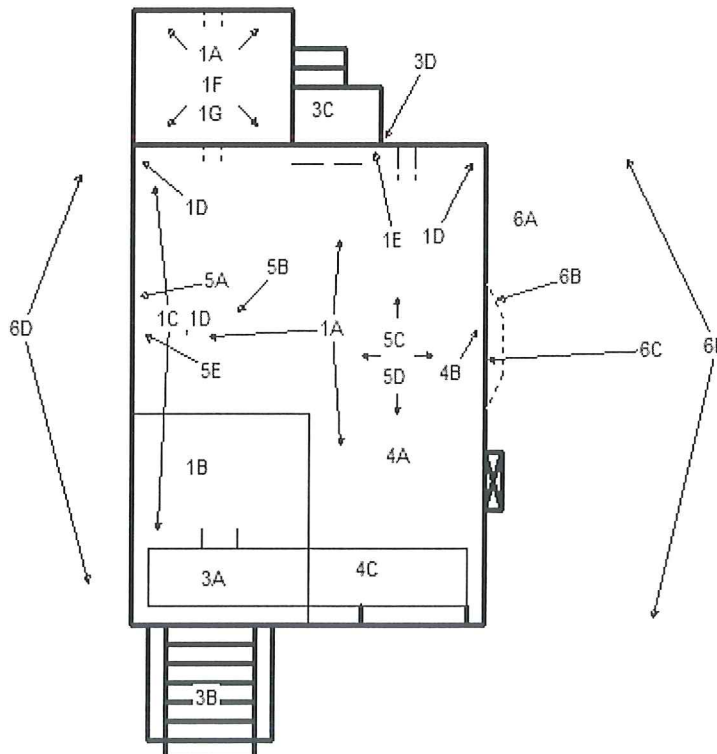
An inspection has been made to the structure(s) shown on the diagram in accordance with the Structural Pest Control Act. Detached porches, detached steps, detached decks and any other structures not on the diagram were not inspected.
